## ACCIDENT RECONSTRUCTION CASE ANALYSIS OF CENTERLINE CROSSING ACCIDENT

**Abstract:** This study presents the accident reconstruction case analysis for a centerline crossing accident between passenger car and bus on curved highway sections through the process of impacted vehicle investigation, accident site survey, and reconstruction analysis. The accident case was reconstructed by using such physical marks and evidence as skid mark, yaw mark, collision scrub, gauge mark, imprint, oil trace, damaged vehicle conditions, and final stopped vehicle position. The principal direction of force on the impacted vehicle and vehicle dynamics after impact are analyzed from comprehensive evaluation of physical evidences. It is found that the passenger car was keeping his lane by 0.13m inside from the centerline while the bus was crossing the centerline by 0.39m.

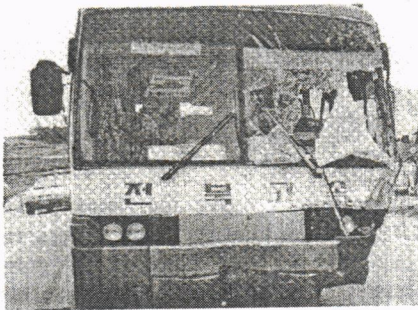
Pictures 1 and 2 show damages on the front and the left body of the bus.

Picture 1. Front Side of Damaged Bus

From the damage characteristics of bus and passenger car shown on the pictures 1, 2, 3, and 4, the first contact is observed at the left-most bumper of the bus and the left of passenger car's grill guard while maximum engagement is observed at two points of the bus; (1) left low part of the body and (2) air vacuum tank, and three points of the passenger car; (1) front left fender, (2) front left filler and (3) inner part of the front left tire.

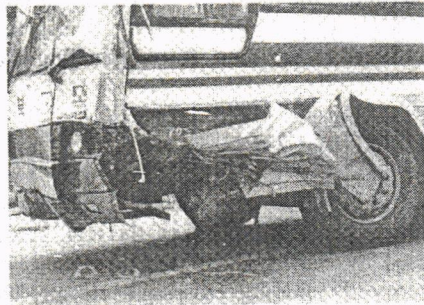
Picture 2. Left Side of Damaged Bus

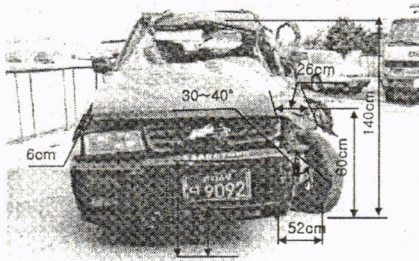
The heights of the grill guard which may be the first contact range from 40 cm to 60 cm. Front part of the left hood was damaged. Its height and depths are 80 cm and 26 cm, respectively. Meanwhile, The left front tire was twisted about  $30^{\circ} \sim 40^{\circ}$  (52 cm away from towing hook) toward left side of the vehicle body at the time of colliding.

Picture 3. Damages on the front

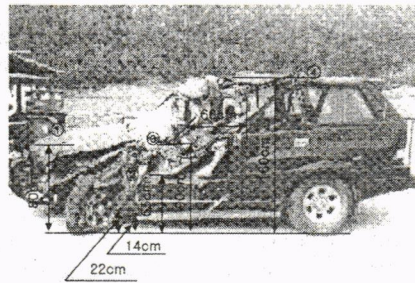
Damages were observed at four different parts, as shown in Picture 4: spot ① 80cm high, spot ② 65cm high, spot ③ 90cm high, and spot ④ 160cm high from the road surface. Spot ④ was a little reshaped by towing. The body of the passenger car is 22 cm high and the step of the driver seat is 14 cm high.

Picture 4. Damages on the left side

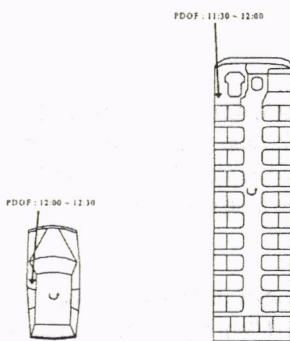
Figure 1 shows the possible PDOF's (Principal Direction of Force) of the bus and passenger car judged from the vehicle's damage characteristics. Turning direction of two vehicles after colliding would be counterclockwise. The passenger car seemed to experience the rapid turning by relatively higher turning force than the bus because of the higher impact force of bus upon passenger car.

Figure 1. PDOF and Turning Directions

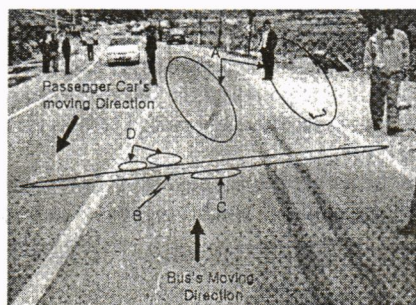
Two tire marks (A, C), two gauge marks (D), and oil trace (B) were shown in Picture 5. Their characteristics and causes are as follows.

Picture 5. Physical Evidences on the Bus Path

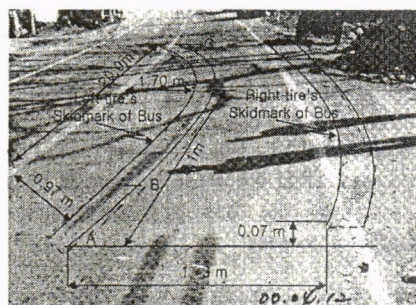
Picture 6. Evidence A

Evidence A is the skid mark of the bus. Picture 6 shows that left tire mark from A to B is skid mark, and from B to thereafter is yaw mark. That is, skid mark was printed by linear moving caused from bigger driving forces than turning forces of the bus while yaw mark was created by bigger turning forces than driving forces.

The skid mark of A by the left tire shown on Picture 6 was started at the point of 0.97 m right side from the centerline. The width between left and right tires is about 1.73 m. The skid mark of the left tire is shown 0.07 m earlier than the right tire skid mark. Rolling movement of the

bus might cause this result. After traveling 8.1 m from the first skid mark, where curvature of the mark changes, the mark was at 1.70m right side from the centerline. This means that the bus traveled diagonally not parallel to the centerline before collision.

Further, it is shown on Picture 6 that the bus crossed the centerline after about 20 m skidding along the centerline from its starting mark of the left tire. Then, it passed the opposite lane, got away from the road and stopped. In the mean time, the bus seemed to decelerate until final stop since yaw mark shows right upward diagonal direction instead of axle direction.

Starting point of bus' front left tire mark was approximately 0.97 m away from the centerline as shown on Picture 6. It goes along with the centerline about 8.1 m where mark's curvature changes. At curvature changing point, the left front tire of bus is 1.70m right side from the centerline. This tells that bus traveled a little bit diagonally to centerline (Out-In-Out), not parallel to the centerline. The analysis by Figure 3 revealed that the bus is crossed centerline at 10.8m downstream from the starting point of skid mark by the left front tire of bus. Therefore, this accident can be explained that bus traveled Out-In-Out, realized a passenger car coming from the opposite lane, tried to go back to its original lane but failed, thus finally collided.

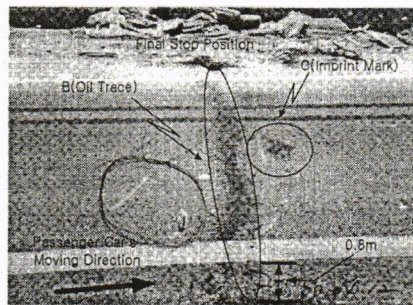
Picture 7 shows passenger car's power oil leaking. It leaked from the lane of passenger car to the final stop position crossed perpendicularly to the centerline. This leaking evidence started about 0.8 m away from the centerline perpendicular to passenger car's moving direction.

Picture 7.Oil Trace and Imprint Mark

Evidence C in Picture 7 is the tire mark, called imprint mark. Passenger car was separated after maximum engagement and its right rear tire passed through the leaked liquid and imprinted oil mark on the road.

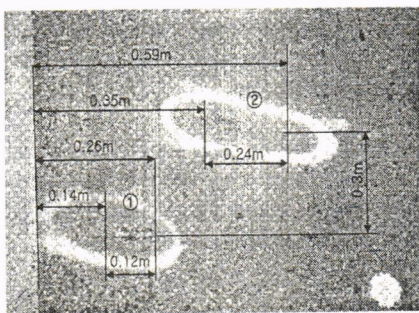
Picture 8 shows two gauge marks (① and ②) on the bus lane. Mark ①, chip, is a kink when heavy metal parts come in contact with the ground with a high pressure. Chip started about 0.14 m right side from the centerline, generated 0.12 m long counterclockwise curve and ended 0.26 m right side from the centerline. Mark ②, chop, is another type of kink when a relatively smaller pressure and wider objects than chip applies. Chop started about 0.21m(0.35m-0.14m) after chip mark ①, 0.35 m right side from the centerline, generated 0.24 m long mark, and ended 0.59 m right side from the centerline. Evidence D was caused through passenger car's path to final stop position after it turned counterclockwise. That is, gravity center of the passenger car abruptly moved into the damaged left front tire and lower part (A, Picture 9) of the passenger car body and contacted the road first and then other lower part (B) of the passenger car body scratched the road surface and finally generated mark ②.

Picture 8. Chip and Scratch Mark

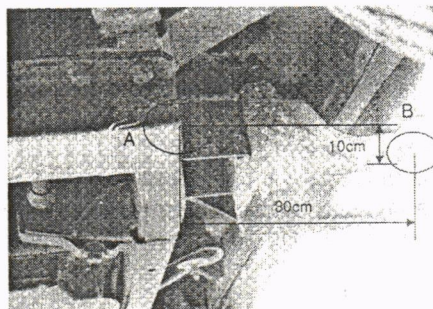
Picture 9. Lower Part Damage of Passenger Car

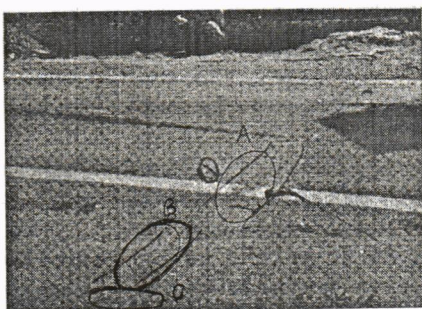
Picture 10 shows three tire marks (A, B and C) on the centerline and passenger car's lane. Evidence A was marked when damaged passenger car's left front tire was crossing the centerline. This centerline crossing stemmed from when the bus instantaneously turned the

passenger car counterclockwise just after maximum engagement.

Evidences B and C were caused by the left and right rear tires when they were sliding counterclockwise. Thicker C was formed because side wall of the right rear tire contacted the road when the passenger car quickly turned counterclockwise and gravity center of the car moved into the right rear tire.

Picture 10. Tire Marks on Passenger Car's Lane

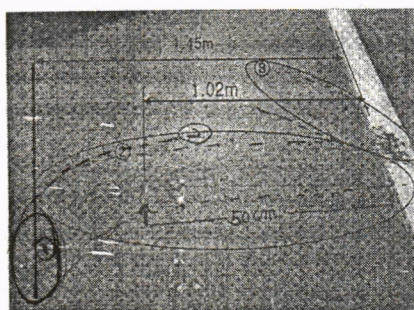
These are very important factors reconstructing the location of the passenger car collision. Picture 11 shows three analyzed parts of C. Part ① of evidence C is, as mentioned above, collision scrub when bus impacted passenger car and they stuck together like cogwheel and passenger car's side wall contacted road surface and made tire tread counterclockwise. Therefore, the starting point of collision scrubs is the position of the passenger car's right rear tire at the time of collision.

Evidence ② follows evidence ① counterclockwise, and it continues until evidence ③ starts. Evidence ③'s starting point is where the passenger car completely separated from the bus and advanced forward after finishing turning counterclockwise. Acceleration scuffs of ③ on the road edge line can be explained by the racing engine force of right rear tire. Crossing angle between evidence ③ and edge of the road is  $42^\circ$ .

Picture 11. Right Rear Tire Marks Character

Distance from evidence ① to the edge of the road is 1.45 m, as shown on Picture 11. This tells that passenger car's right rear tire was located at 1.45 m away from the right edge of the road at the time of collision and the passenger car started to turn counterclockwise. By that time, passenger car's left rear tire location was about 2.97 m ( $1.45 \text{ m} + 1.52 \text{ m}$  of rear track width) away from the edge of the road. This means that the passenger car safely traveled 0.13 m (lane width of 3.1 m - 2.97 m) right side from the centerline at the time of collision.

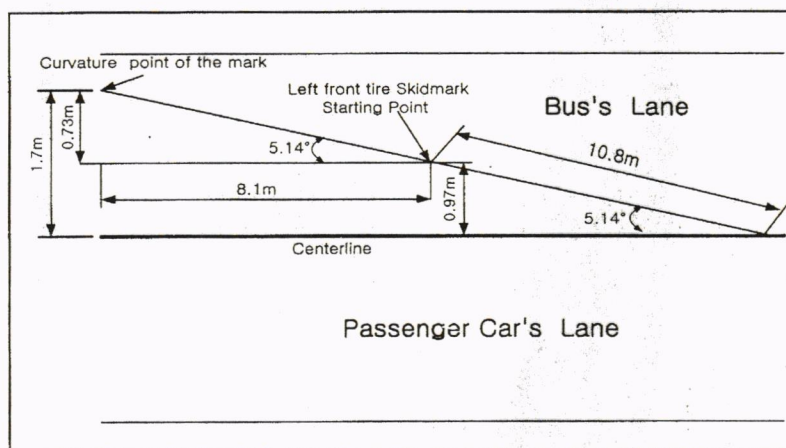
Figure 3. Collision Location Analysis of Bus Left Front Tire

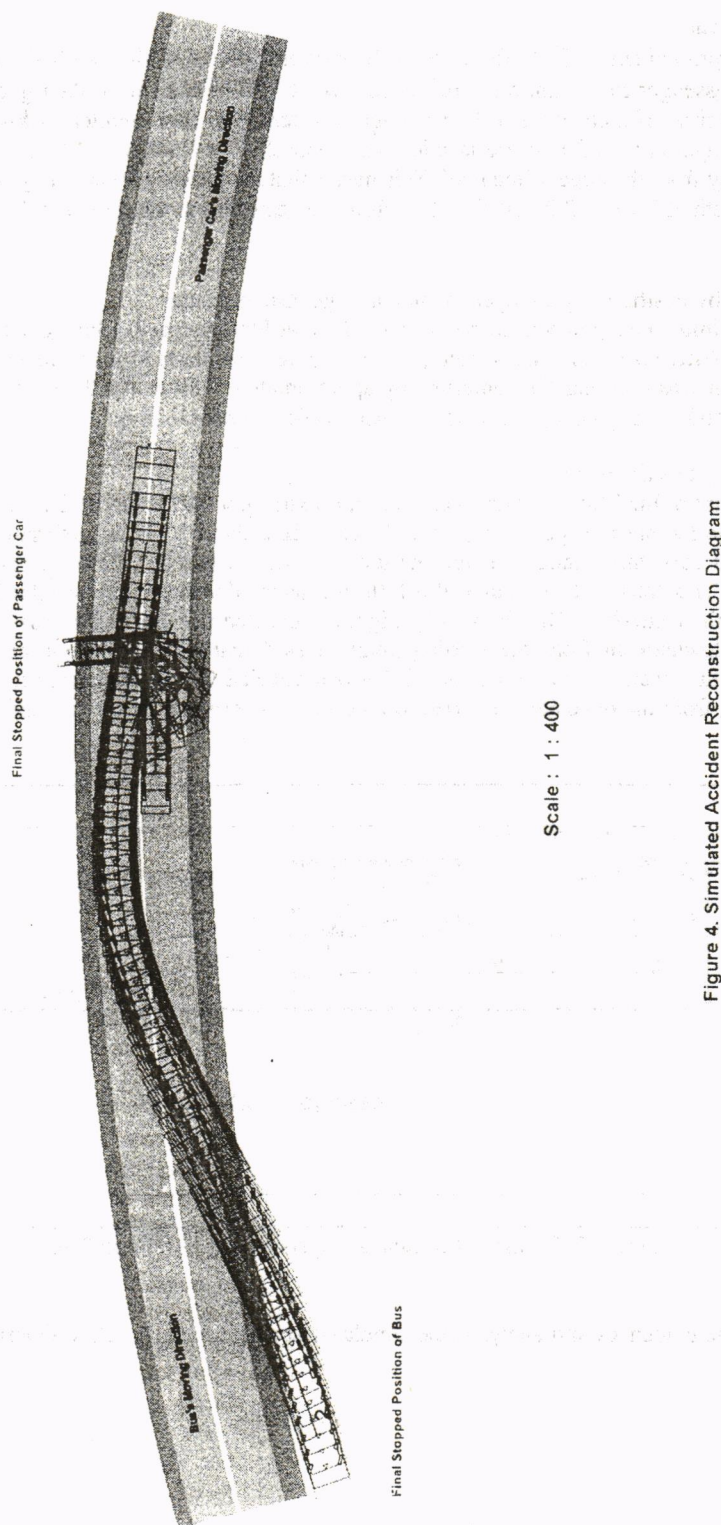
From all the evidences and analysis, the simulated accident reconstruction diagram is drawn as Figure 4.

Figure 4. Simulated Accident Reconstruction Diagram
