PRACTICAL EARTH ANCHORING TECHNOLOGY FOR STRENGTHENING SLOPE WALL PROTECTION (CASE STUDY: DG. SIRUA ROAD POST CONSTRUCTION FAILURE WITH SKYHOOK – GRID BEAM TECHNOLOGY IN MAKASSAR CITY – INDONESIA)

Abstract: The application of soil anchoring system and grid beam method of strengthening protection wall post construction failure was observed in this research. The construction of the slope wall protection is situated to suit the existence of barrier made for aqueduct. Based on the numerical simulation on scenario of potential causes of slope failure, it indicates several phenomena such as the stability of barrier foundation experiences drastic drop. Scrutinizing the result of investigation and ideal design criterion for structural element of barriers, the condition function of existing protection wall has the factor of slope stability $SF=1.01\sim1.09$, which is categorized as not safe and condition barrier failure. The strengthening method of soil anchoring (Skyhook Earth Anchor, with the capacity of 4 tons) which is combined with grid beam manages to improve the barrier's stability to $SF=1.24\sim1.46$ post construction and reduce horizontal displacement of barrier.

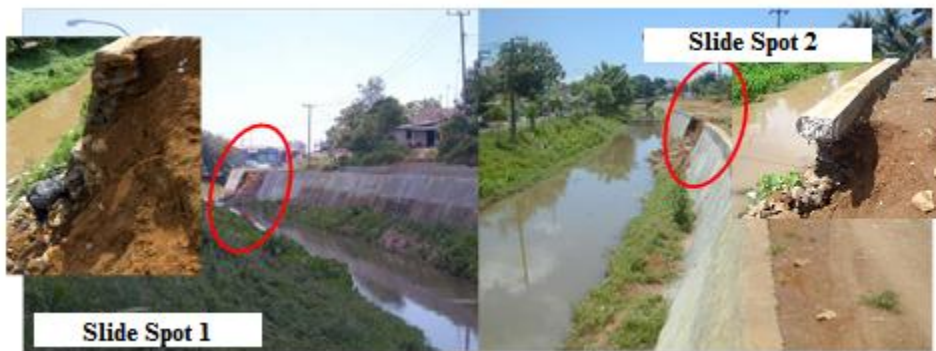
Based on the field observation and surveys of the causes of slide barrier (Zubair, A. et. al., 2011), the initial assumption of this slide is the failure of foundation of barrier which is not constructed above the relatively stable soil in the depth of 4.2-5 meter from the surface. Because of the stability of barrier which is disturbed heavily and the huge deformation, it has induced the crack in the river stone masonry barrier which is ductile and even failure on some spot. The barrier which hasn't experienced the slide but has shown the indication of failure can be seen in Figure 2.

Figure 2. The condition of barrier slide (Slide 1, Sta. 0+650) and (Slide 2, Sta. 0+950)

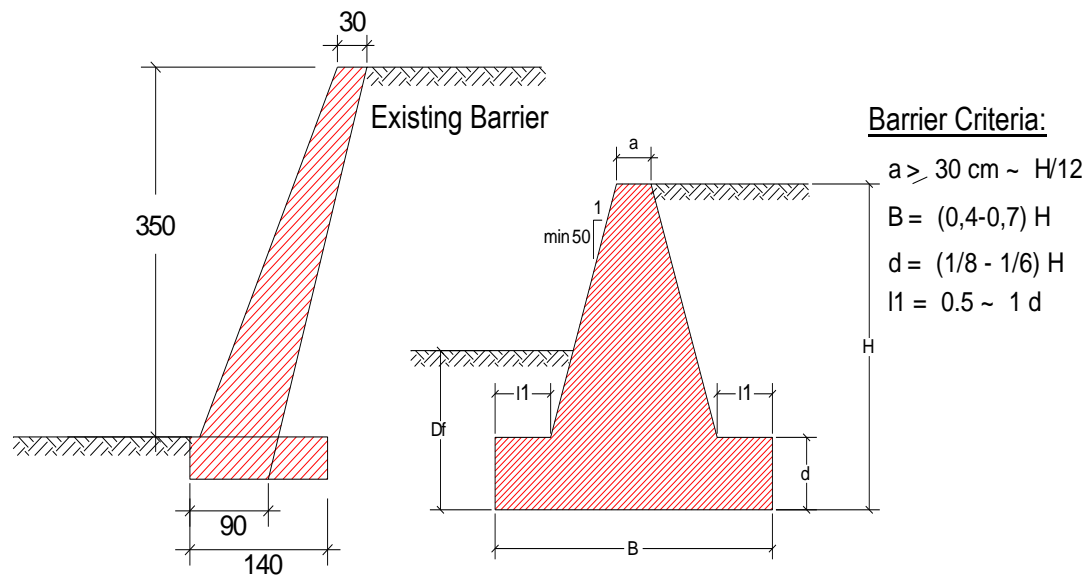
- The bad quality of material such as river stone and specie; river stone is easy to be dismember with its specie by hand, the brownish surface layer of stone patches on specie and the wall of barrier is partially minimum with specie.
- The function of pipe of barrier drainage throughout barrier is not adequate in terms of quantity and diameter.
- The red soil has the slope post the failure around 60° , this will decrease the amount of lateral load of active soil which works on barrier.
- The layer of stone lies on the shallow depth.
- The effective width of existing foundation base of 90 cm, as can be seen in Figure 3, is not adequate for the barrier with the height of 350 cm.

Figure 3. The condition of barrier (Existing Barrier Jln. Dg Sirua) and criteria for stable barrier

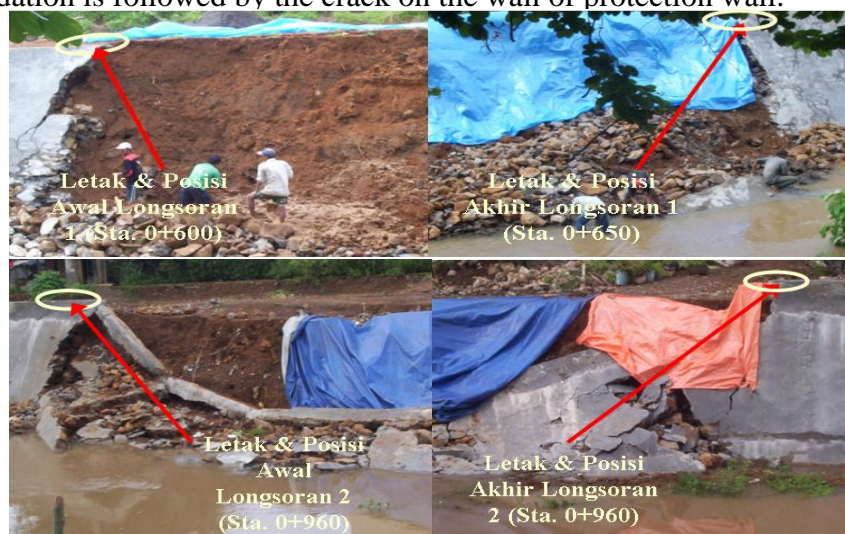
Based on the survey's documentation, the pattern and the condition of slide can be visualized which is shown in Figure 4. The failure of soil protection wall on the pattern of slide on the base of foundation is followed by the crack on the wall of protection wall.

Figure 4. The pattern of failure for both slide spots, Jln. Inspeksi Saluran Air Baku PDAM Kota Makassar.

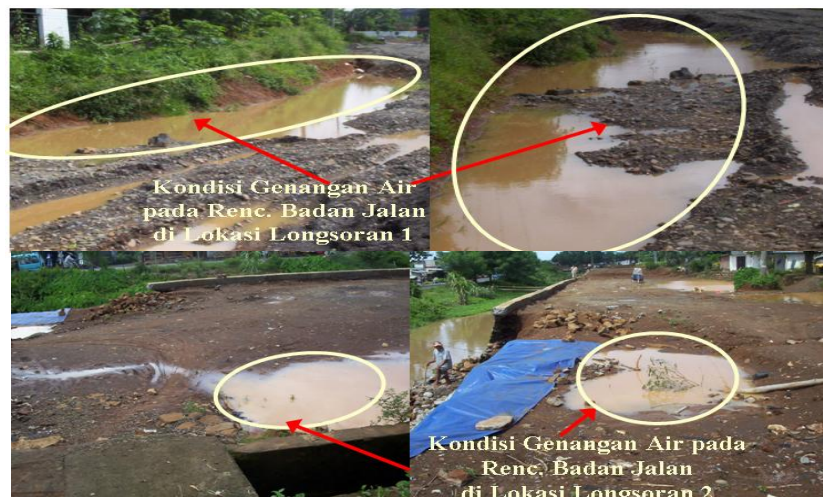
The drainage on the surface of slide which is visualized in Figure 5 is in very bad condition. The potential puddle saturates the layers of surface or high water infiltration table.

Figure 5. The pattern of failure for both slide spots, Jln. Inspeksi Saluran Air Baku PDAM Kota Makassar.

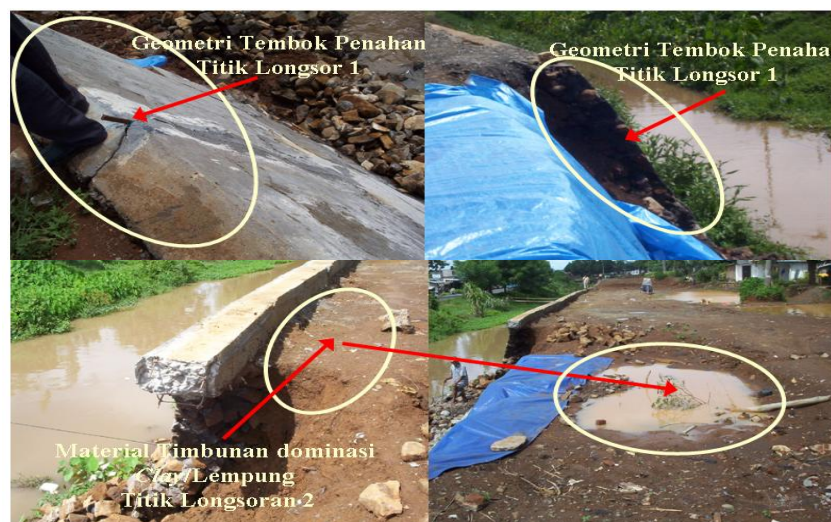
The drainage on the surface of slide which is visualized in Figure 6 is in very bad condition. The potential puddle saturates the layers of surface or high water infiltration table.

Figure 6. The construction material for pavement and protection wall at both slide spots.

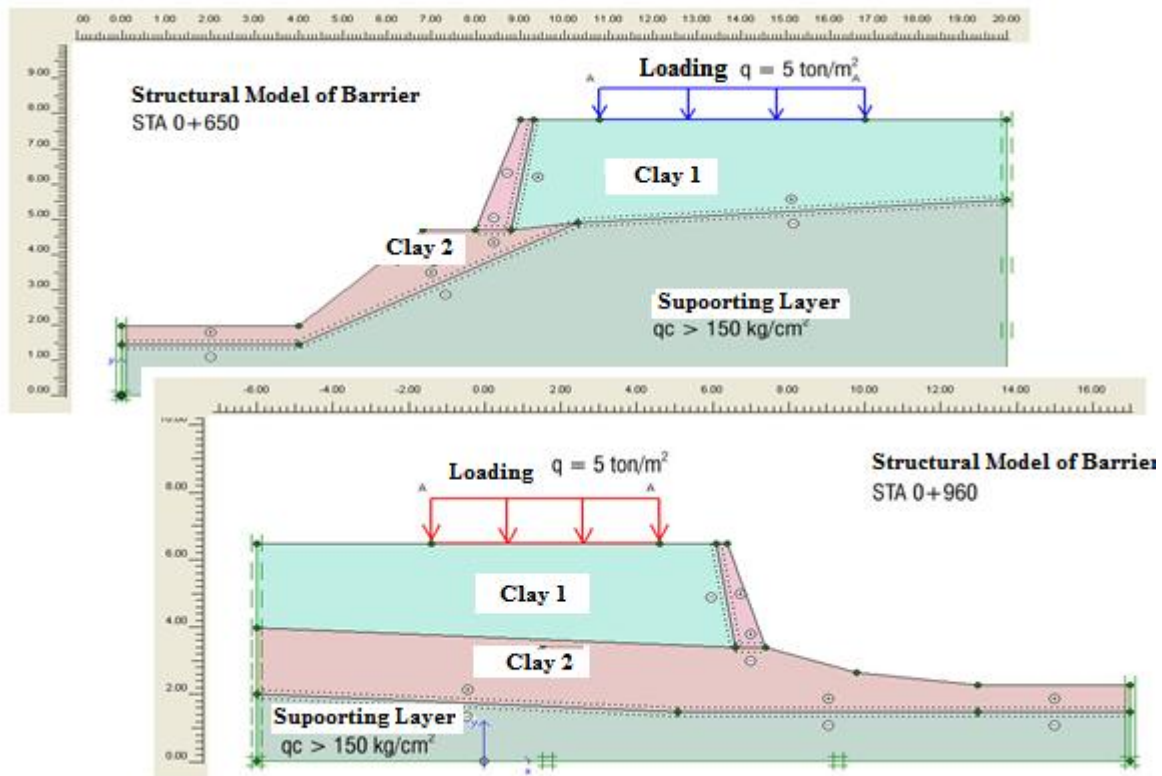
The geometry of barrier which is used on this reinforcement analysis is modelled based on the sectional profile of slide prototype at the slide spot along the road which is illustrated in Figure 7. The mechanism of slide which has occurred is simulated with the packet of numerical simulation and refers to the model of soil profile and the prediction of ground water table when the slide occurred.

Figure 7 Structural Model of Existing Barrier Jln. Dg Sirua Makassar, Slide Spot 1 (Sta. 0+650) and 2 (Sta. 0+960)

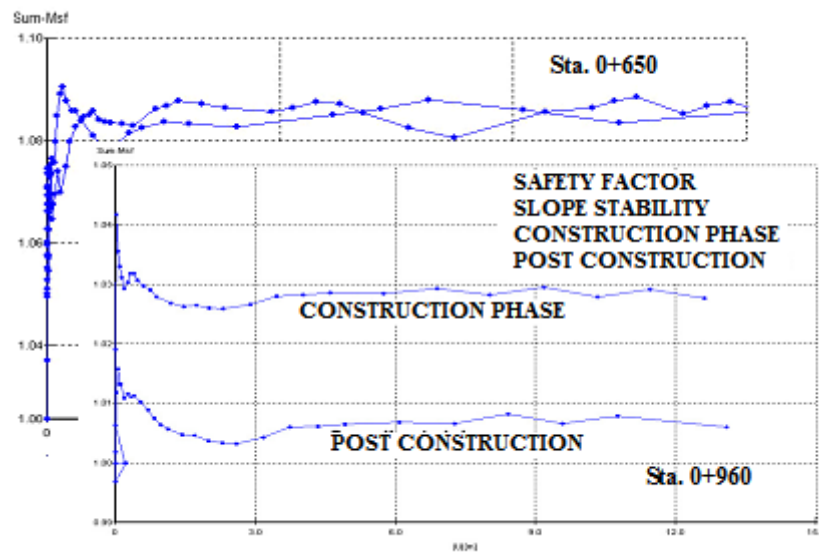
Figure 8. The value of existing barrier's stability Jln. Dg Sirua Makassar, Slide Spot 1 (Sta. 0+650) and 2 (Sta. 0+960)

When the slide occurred, the stability factor of slope are $S_F=1.08\sim1.09$ (Slide Spot 1) and $S_F=1.01\sim1.03$ (Slide Spot 2). This value of stability is categorized as inadequate, lower than the value of criteria which is $S_F=1.5$ and the value S_F was lower than than the phase of post construction.

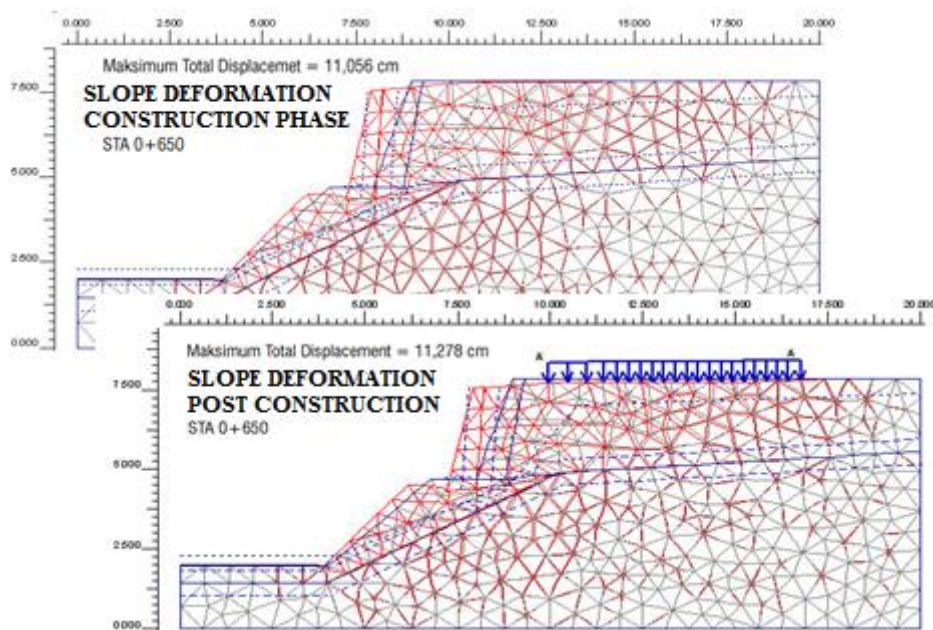
Based on the numerical simulation, it can be justified that the deformation of existing barrier when the slide occurred was 11.056~11.278 cm (slide spot 1) dan 20.85~22.55 cm (slide spot 2) toward the channel of PDAM. Such potential horizontal movement is categorized as critical because it will potentially induce destruction on the structure of existing barrier.

Figure 9. The potential deformation of existing barrier Jln. Dg Sirua Makassar, Slide spot 1 (Sta. 0+650)

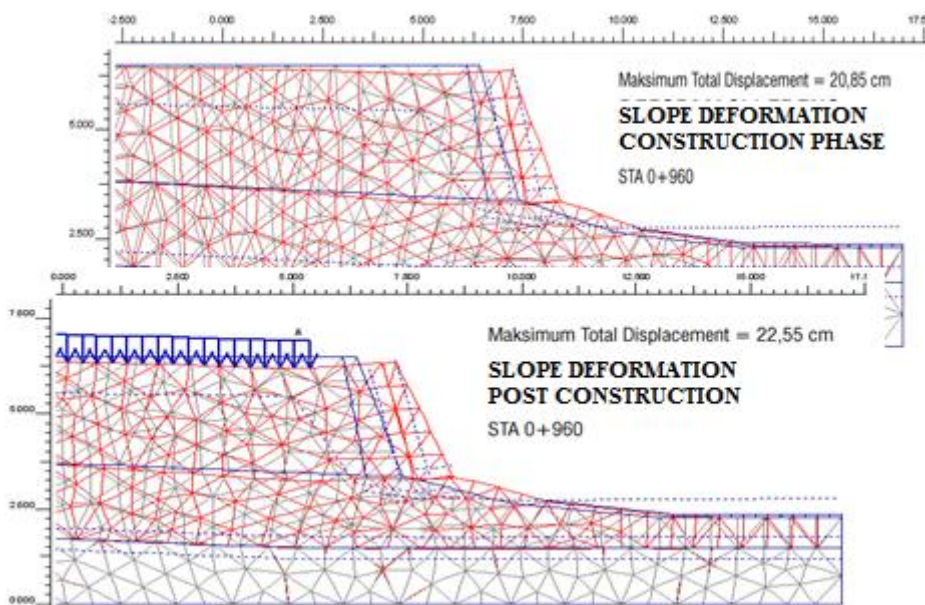
Figure 10. The potential deformation of existing barrier Jln. Dg Sirua Makassar, Slide Spot 2 (Sta. 0+960)

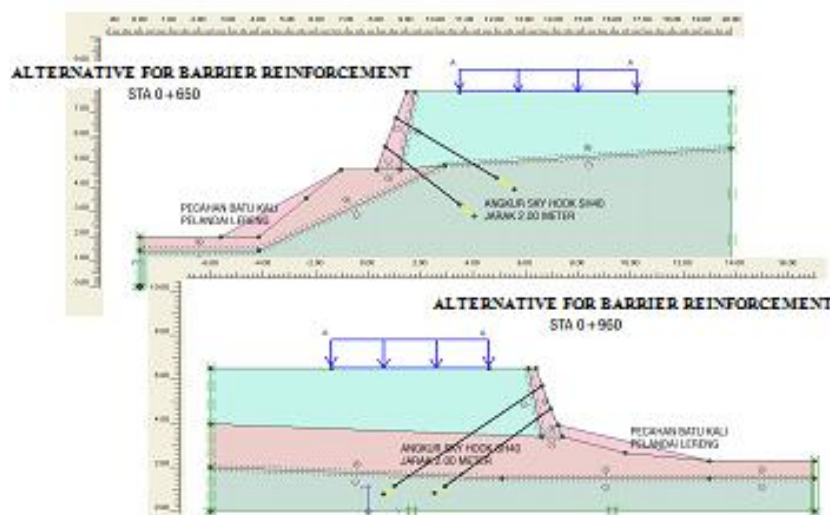
Figure 11. Structural model of barrier strengthening by anchor Jln. Dg Sirua Makassar, Slide Spot 1 (Sta. 0+650) and 2 (Sta. 0+960)

After obtaining several alternatives, the economical solution to strengthen the barrier is the application of anchor with structural model as described in Figure 11. Such strengthening model is congruent with the suggestion of *barrier strengthening and the rehabilitation of road pavement*, material of subbase embankment with Sirtu selected materials (Samang, L. et. al., 2006).

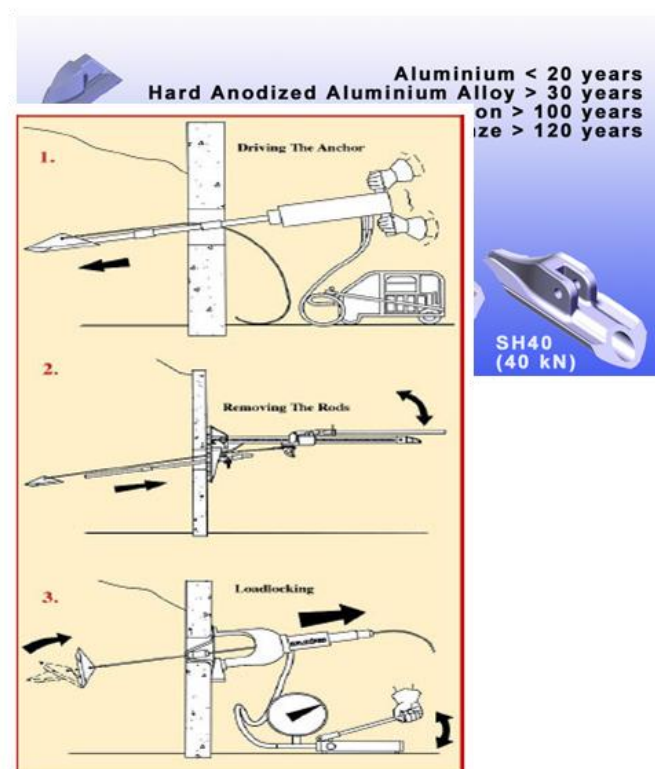
Figure 12. The picture of anchor material and the phase of anchor installation with the strain capacity of 40 kN (type SH40)

The design parameter and barrier construction which is employed in this analysis is the same with the Table 2 and the design parameter for soil anchor with specification of SkyHook Earth Anchor with the capacity of 4 ton type SH40; the value of stiffness $EA = 23.700 \text{ kN}$, strain of anchor $F_{\text{max}} = 20 \text{ kN}$ with the assumption of $S_F = 2$, and the distance between installed anchor $L_s = 2.5 \text{ m}$. The visualization of anchor material and its installation is illustrated in Figure 12

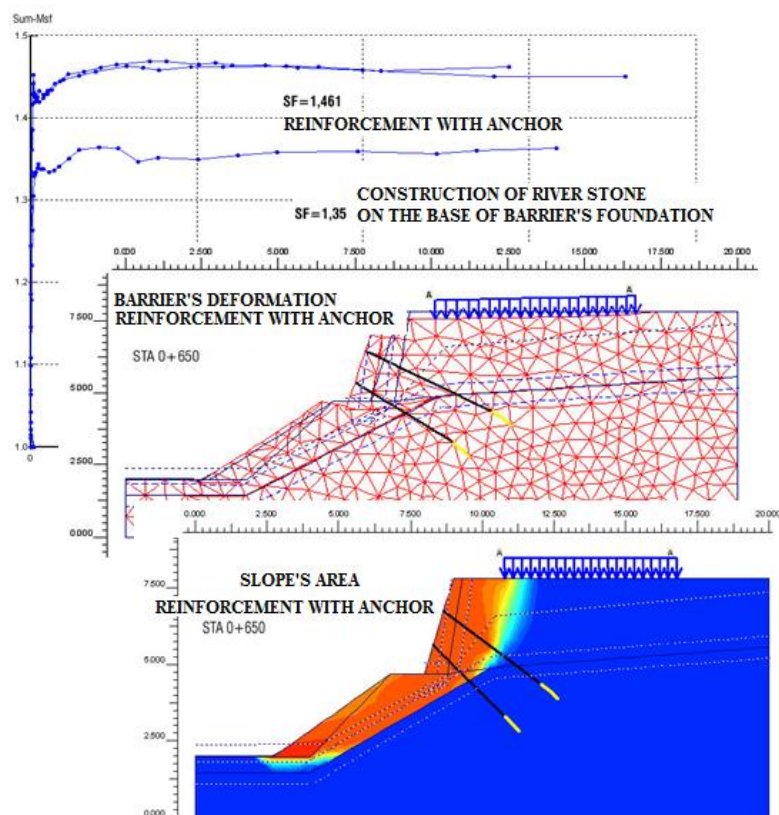
The performance of anchor in Slide Zone 1 managed to increase the value of stability from 1.42-1.46 after phase of construction. The deformation post construction at 0+650 is 4.2 cm and the safety factor of slopes as well as the area of slide post construction is illustrated in Figure 13. The use of protection layer of barrier's foundation base without anchor is not effective to increase the barrier's stability.

Figure 13. The value of stability, deformation and the pattern of slide area post installation of soil's anchor at slide zone 1.

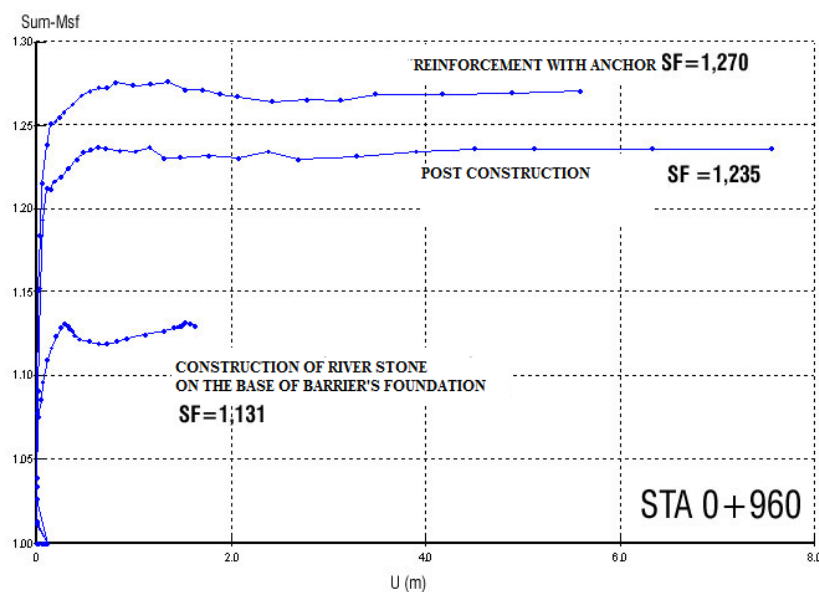
The performance of anchor in Slide Zone 2 managed to increase the value of stability from 1.24-1.27 after phase of construction, the increase of S_F is not significant which can be seen in Figure 14. The deformation post construction at 0+650 is 12.4 cm and the safety factor of slopes as well as the area of slide post construction is illustrated in Figure 15. The reduction of horizontal deformation is moderately significant. The use of protection layer of barrier's foundation base without anchor is not effective to increase the barrier's stability, but can be considered as the protection layer of potential infiltration.

Figure 14. The value of slope stability after the installation of soil's anchor at slide zone 2.

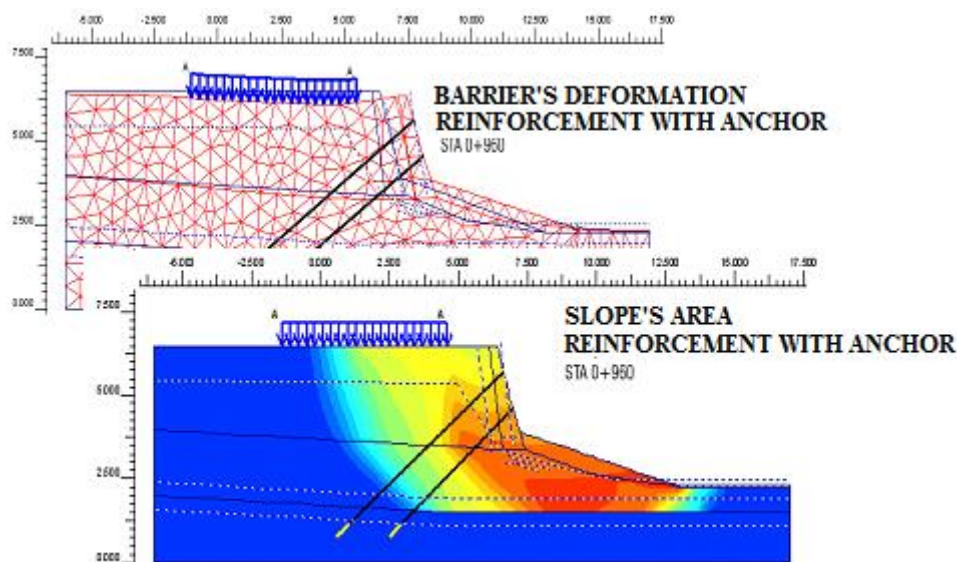
Figure 15. The potential deformation and the pattern of slide area after the installation of soil's anchor at slide zone 2.
