PRACTICAL EARTH ANCHORING TECHNOLOGY FOR STRENGTHENING SLOPE WALL PROTECTION (CASE STUDY: DG. SIRUA ROAD POST CONSTRUCTION FAILURE WITH SKYHOOK – GRID BEAM TECHNOLOGY IN MAKASSAR CITY – INDONESIA)

Abstract: The application of soil anchoring system and grid beam method of strengthening protection wall post construction failure was observed in this research. The construction of the slope wall protection is situated to suit the existence of barrier made for aqueduct. Based on the numerical simulation on scenario of potential causes of slope failure, it indicates several phenomena such as the stability of barrier foundation experiences drastic drop. Scrutinizing the result of investigation and ideal design criterion for structural element of barriers, the condition function of existing protection wall has the factor of slope stability $SF=1.01\sim 1.09$, which is categorized as not safe and condition barrier failure. The strengthening method of soil anchoring (Skyhook Earth Anchor, with the capacity of 4 tons) which is combined with grid beam manages to improve the barrier's stability to $SF=1.24\sim 1.46$ post construction and reduce horizontal displacement of barrier.

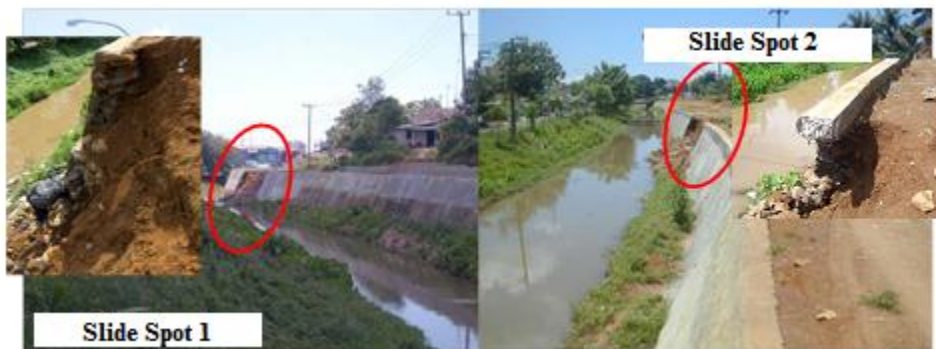
Based on the field observation and surveys of the causes of slide barrier (Zubair, A. et. al., 2011), the initial assumption of this slide is the failure of foundation of barrier which is not constructed above the relatively stable soil in the depth of 4.2-5 meter from the surface. Because of the stability of barrier which is disturbed heavily and the huge deformation, it has induced the crack in the river stone masonry barrier which is ductile and even failure on some spot. The barrier which hasn't experienced the slide but has shown the indication of failure can be seen in Figure 2.

Figure 2. The condition of barrier slide (Slide 1, Sta. 0+650) and (Slide 2, Sta. 0+950)

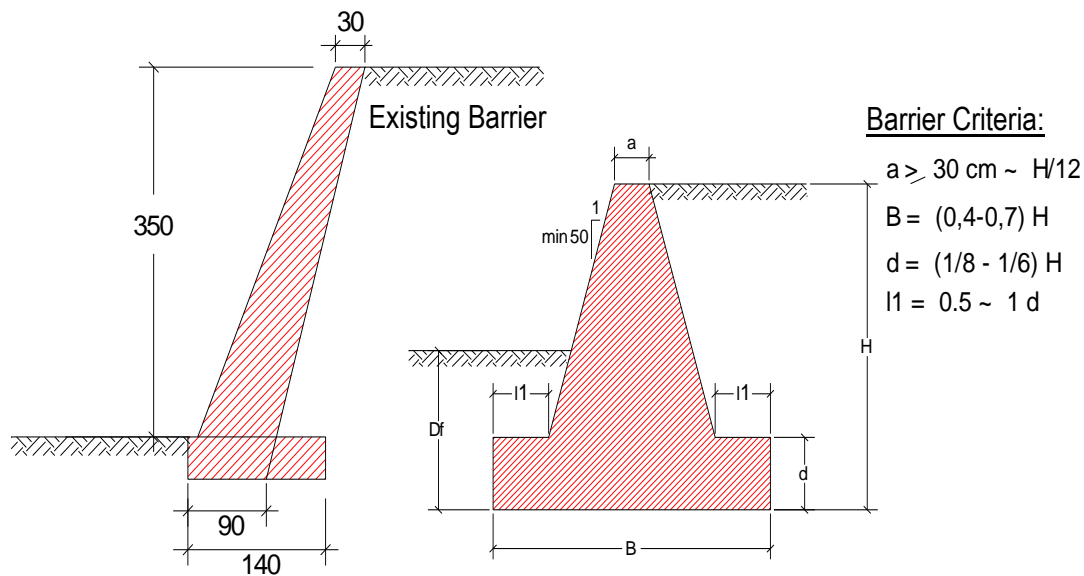
- The bad quality of material such as river stone and specie; river stone is easy to be dismember with its specie by hand, the brownish surface layer of stone patches on specie and the wall of barrier is partially minimum with specie.
- The function of pipe of barrier drainage throughout barrier is not adequate in terms of quantity and diameter.
- The red soil has the slope post the failure around 60° , this will decrease the amount of lateral load of active soil which works on barrier.
- The layer of stone lies on the shallow depth.
- The effective width of existing foundation base of 90 cm, as can be seen in Figure 3, is not adequate for the barrier with the height of 350 cm.

Figure 3. The condition of barrier (Existing Barrier Jln. Dg Sirua) and criteria for stable barrier

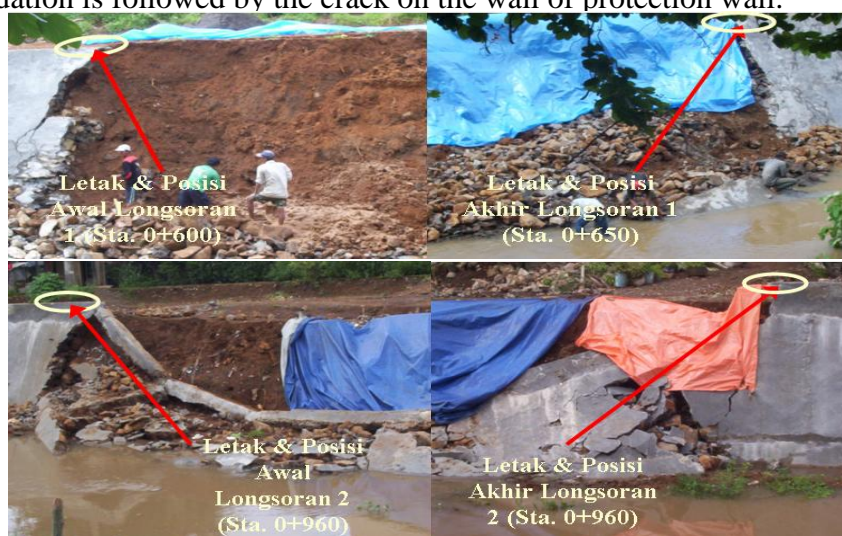
Based on the survey's documentation, the pattern and the condition of slide can be visualized which is shown in Figure 4. The failure of soil protection wall on the pattern of slide on the base of foundation is followed by the crack on the wall of protection wall.

Figure 4. The pattern of failure for both slide spots, Jln. Inspeksi Saluran Air Baku PDAM Kota Makassar.

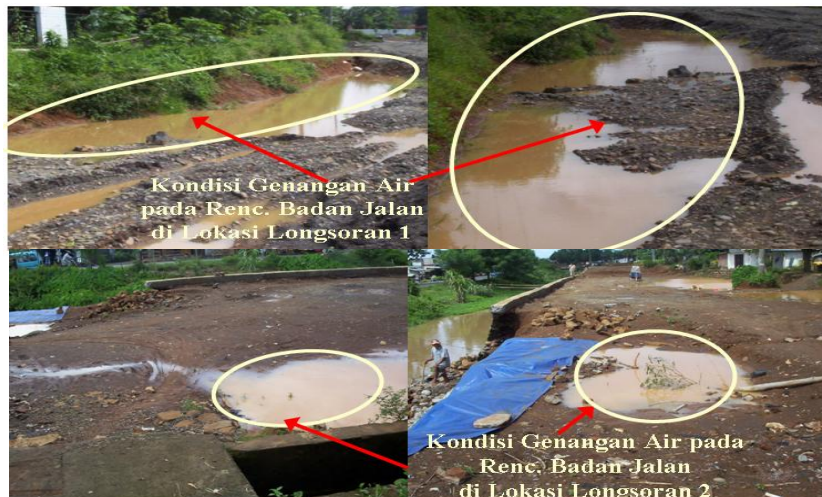
The drainage on the surface of slide which is visualized in Figure 5 is in very bad condition. The potential puddle saturates the layers of surface or high water infiltration table.

Figure 5. The pattern of failure for both slide spots, Jln. Inspeksi Saluran Air Baku PDAM Kota Makassar.

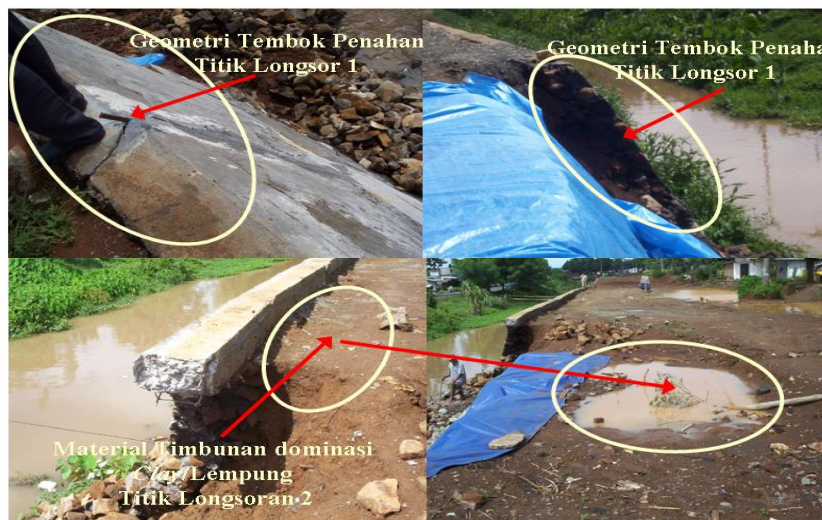
The drainage on the surface of slide which is visualized in Figure 6 is in very bad condition. The potential puddle saturates the layers of surface or high water infiltration table.

Figure 6. The construction material for pavement and protection wall at both slide spots.

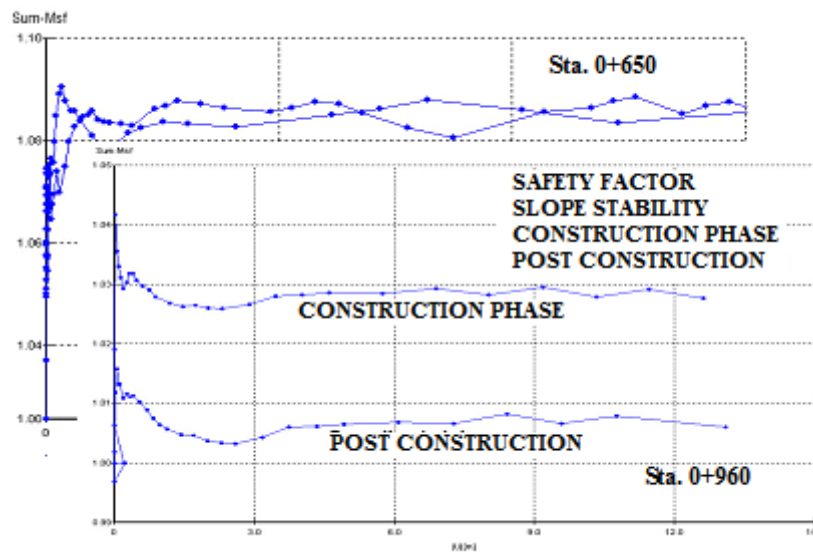
Figure 8. The value of existing barrier's stability Jln. Dg Sirua Makassar, Slide Spot 1 (Sta. 0+650) and 2 (Sta. 0+960)

When the slide occurred, the stability factor of slope are $S_F=1.08\sim1.09$ (Slide Spot 1) and $S_F=1.01\sim1.03$ (Slide Spot 2). This value of stability is categorized as inadequate, lower than the value of criteria which is $S_F=1.5$ and the value S_F was lower than than the phase of post construction.

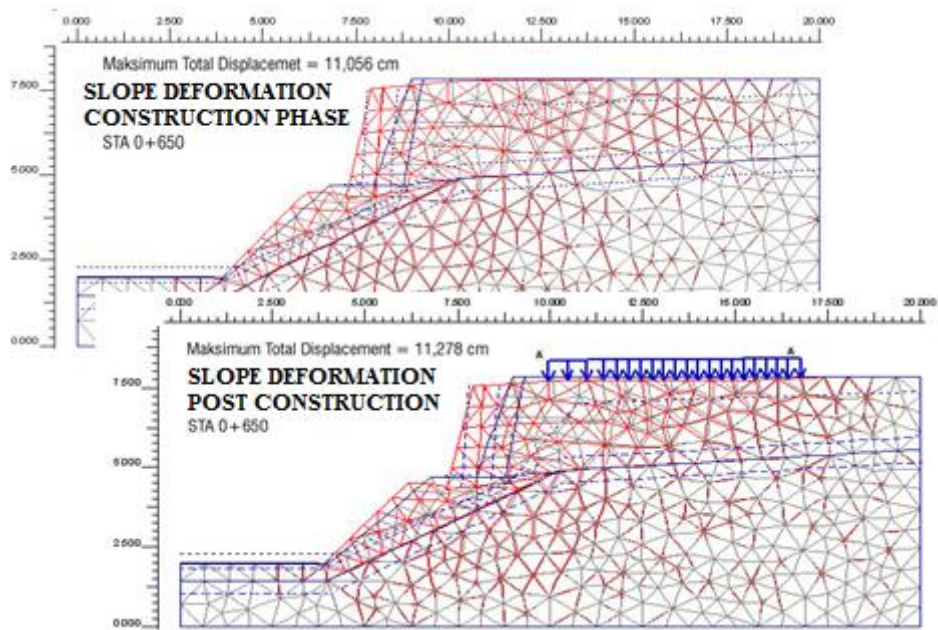
Based on the numerical simulation, it can be justified that the deformation of existing barrier when the slide occurred was 11.056~11.278 cm (slide spot 1) dan 20.85~22.55 cm (slide spot 2) toward the channel of PDAM. Such potential horizontal movement is categorized as critical because it will potentially induce destruction on the structure of existing barrier.

Figure 9. The potential deformation of existing barrier Jln. Dg Sirua Makassar, Slide spot 1 (Sta. 0+650)

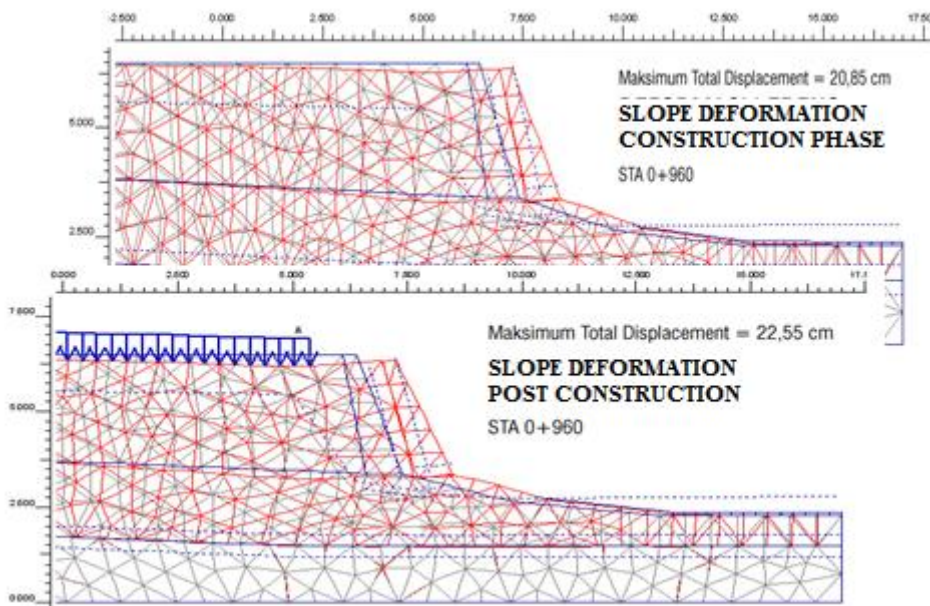
Figure 10. The potential deformation of existing barrier Jln. Dg Sirua Makassar, Slide Spot 2 (Sta. 0+960)

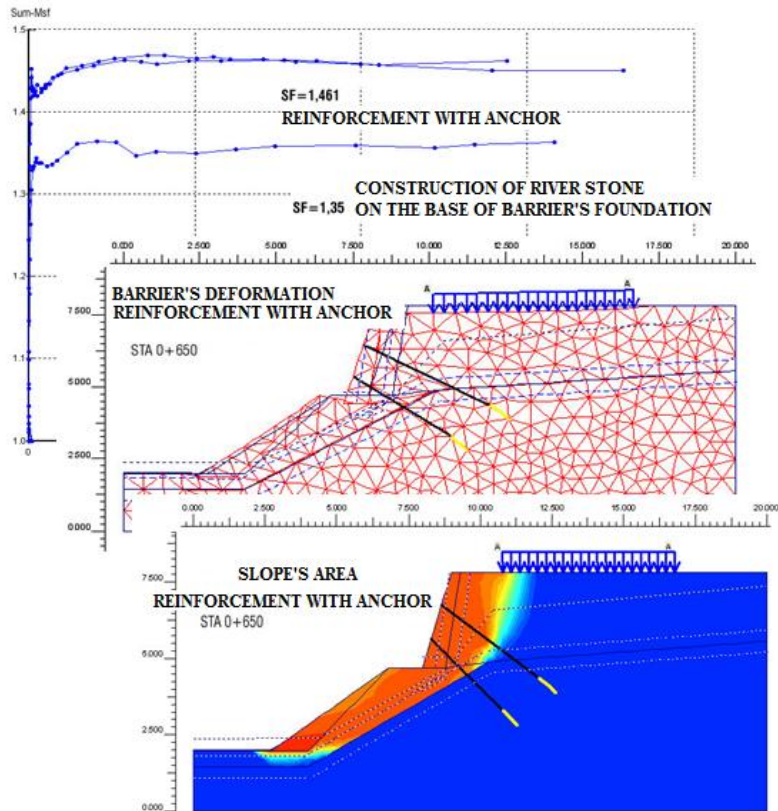
The performance of anchor in Slide Zone 1 managed to increase the value of stability from 1.42-1.46 after phase of construction. The deformation post construction at 0+650 is 4.2 cm and the safety factor of slopes as well as the area of slide post construction is illustrated in Figure 13. The use of protection layer of barrier's foundation base without anchor is not effective to increase the barrier's stability.

Figure 13. The value of stability, deformation and the pattern of slide area post installation of soil's anchor at slide zone 1.

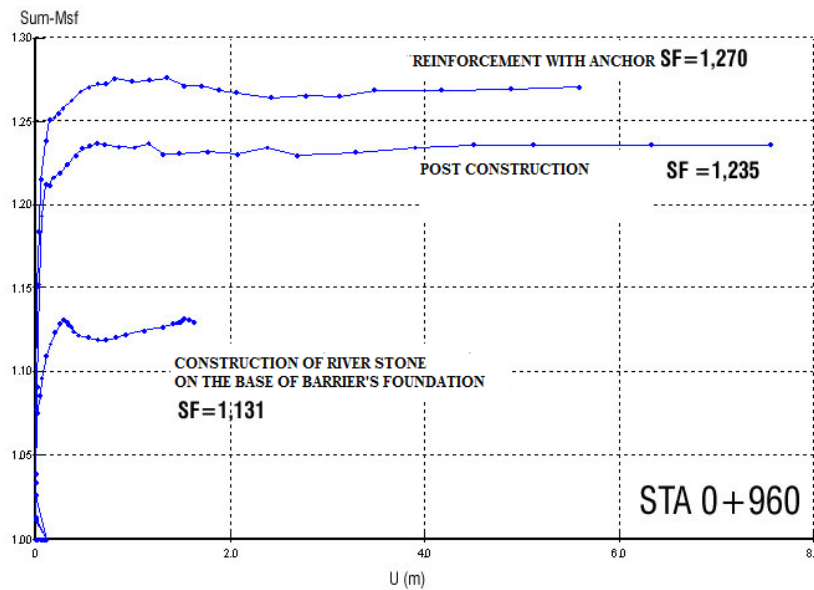
The performance of anchor in Slide Zone 2 managed to increase the value of stability from 1.24-1.27 after phase of construction, the increase of S_F is not significant which can be seen in Figure 14. The deformation post construction at 0+650 is 12.4 cm and the safety factor of slopes as well as the area of slide post construction is illustrated in Figure 15. The reduction of horizontal deformation is moderately significant. The use of protection layer of barrier's foundation base without anchor is not effective to increase the barrier's stability, but can be considered as the protection layer of potential infiltration.

Figure 14. The value of slope stability after the installation of soil's anchor at slide zone 2.

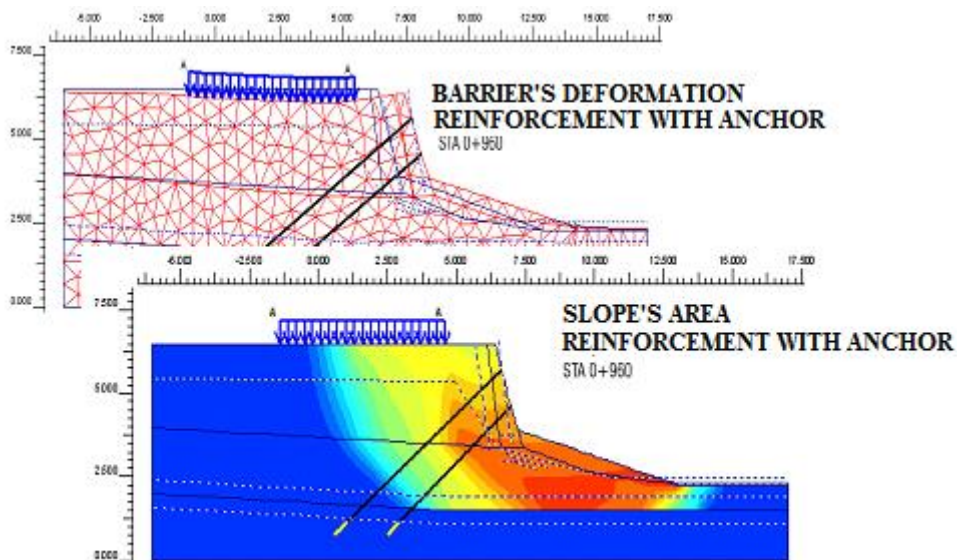
Figure 15. The potential deformation and the pattern of slide area after the installation of soil's anchor at slide zone 2.
