### 3. PANTURA JAVA NATIONAL ROAD, INDONESIA

### 4. DATA COLLECTION

## 5. ROAD SAFETY ANALYSIS

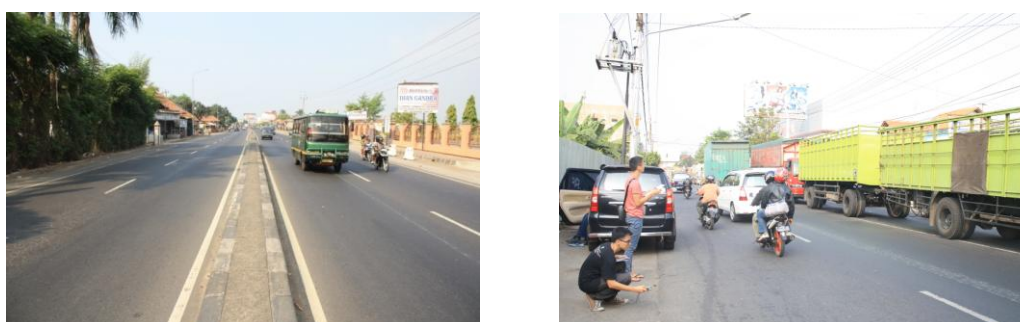
Figure 2. National road Sutomo, Pekalongan Kota, Centre Java, Indonesia.

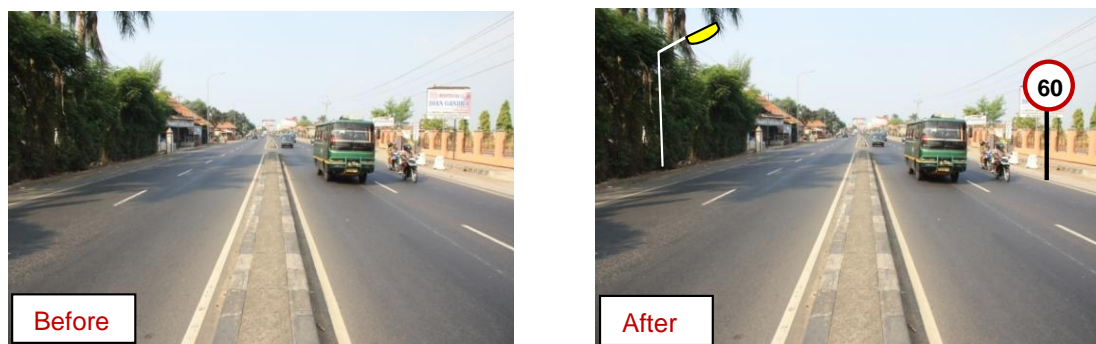
Figure 3. Detail recommended solutions in increasing road safety deficiency and making road safer at Location 6 Centre Java, Indonesia.

Using Table 2, Table 3, and Table 4, analysis to determine blackspot location is done. For example, road safety deficiency analysis based on field data of location 6 is provided in Table 5a, Table 5b, and Table 5c. The same analysis is done to other locations. Action program to decrease road safety deficiency and making road safer for all locations is presented in Table 6. Furthermore, Figure 3 presents example of detail recommended solutions in increasing road safety deficiency in order to make safer road of Location 6 i.e. implementation of speed limit sign and road lighting along the road.
