Road Safety Improvement in Developing Country Case Study on National Road in Indonesia

A. Caroline SUTANDI^a, Wimpy SANTOSA^b

*^{a,b} Civil Engineering Department, Faculty of Engineering, Parahyangan Catholic
University, Ciumbuleuit 94, Bandung 40141, Indonesia*

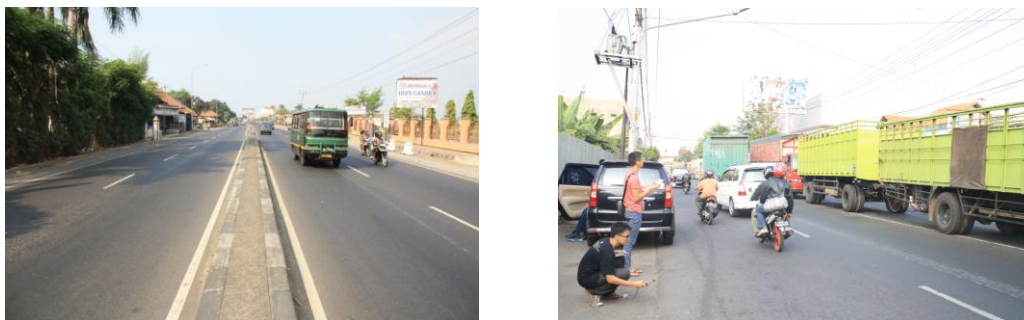
Figure 2. National road Sutomo, Pekalongan Kota, Centre Java, Indonesia.

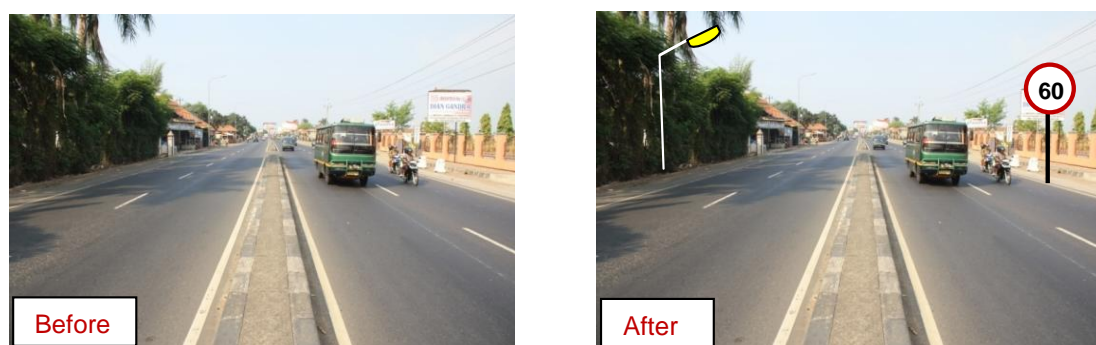
Using Table 2, Table 3, and Table 4, analysis to determine blackspot location is done. For example, road safety deficiency analysis based on field data of location 6 is provided in Table 5a, Table 5b, and Table 5c. The same analysis is done to other locations. Action program to decrease road safety deficiency and making road safer for all locations is presented in Table 6. Furthermore, Figure 3 presents example of detail recommended solutions in increasing road safety deficiency in order to make safer road of Location 6 i.e. implementation of speed limit sign and road lighting along the road.

Figure 3. Detail recommended solutions in increasing road safety deficiency and making road safer at Location 6 Centre Java, Indonesia.
