THE SAFETY PERFORMANCE EVALUATION OF POLYETHYLENE BARRIERS

Key Words: longitudinal barrier, crash test, polyethylene, safety, performance

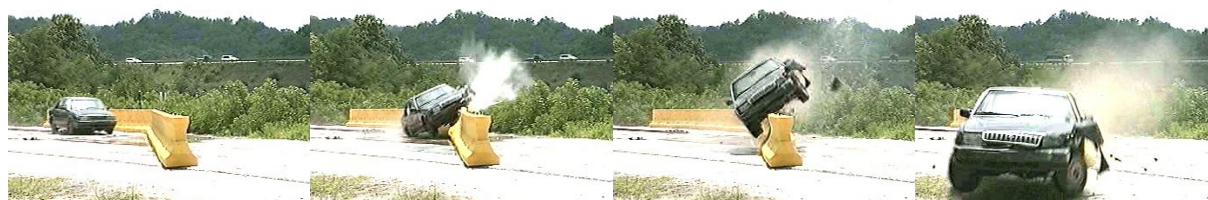
Figure 1. Real Collision Testing Against Green Safety Box

The real collision tests against these two types of polyethylene protective barriers are depicted in Figure 1 and Figure 2 below.

As previously described, the performance of the protective barriers on the protection of the riders is evaluated by a comprehensive assessment on THIV (Theoretical Head Impact Velocity), PHD (Post-impact Head Deceleration) and the damage caused by flying of dismantled structural components. For the case of green safety box, THIV and PHD were measured at 5.22m/s and 5.37g, respectively, within the limits of safety standards set forth.

Another safety requirement is that the damage caused by flying of structural components of the barrier above and outside the traffic lanes after the collision should not seriously effect the riders or other third party such as pedestrians. This requirement was again satisfactorily met by the visual inspection, which revealed seriously damaged 4 units and slightly scratched 8 units. It was determined that this damage after the impact was not enough to have some structural components of the barrier dismantled and flown in the air. The damage assessment revealed that 4 units of 1.5m were to be replaced, attesting to fairly satisfactory performance of the barrier. The lengthwise and the maximum crosswise distance of deformity of the barrier were measured at 14.45m and 0.62m, respectively.

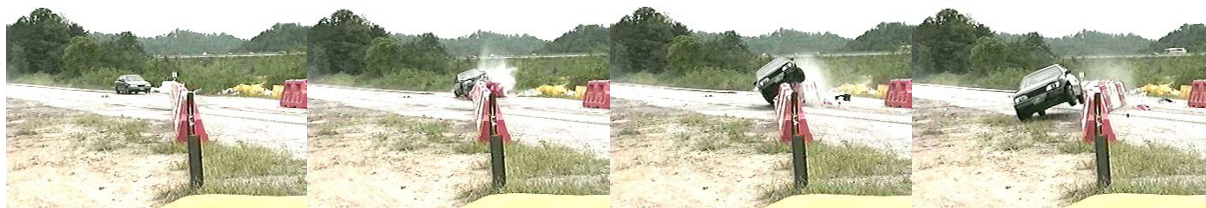
Figure 2. Real Collision Testing Against Guard Box

The collision test by a real vehicle against the guard box exhibited 6.41m/s and 8.52g for THIV and PHD, respectively. These values meet the standards satisfactorily. It also showed serious damaged units of 3 and slightly scratched units of 7, thus, indicating that the damage caused by possible flying structural components would not be enough to be concerned. Three units of 2.0m were to be replaced, a rather satisfactory result. The lengthwise and maximum crosswise deformed length were measured at 23.2m and 1.09m, respectively.

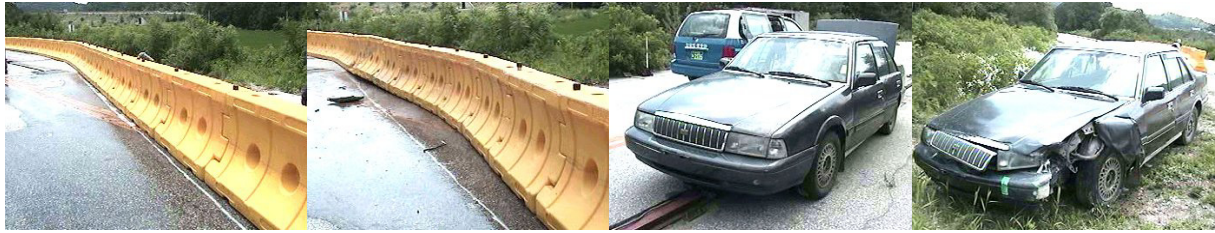
Figure 3. The testing vehicle and barrier before and after the collision test - Green Safety Box

The movement behavior of the colliding vehicle was then analyzed and evaluated. It is stipulated that breaking away of the colliding vehicle should not occur, and the deflected angle of the vehicle should be less than 12° , which is 60% of the assumed colliding angle. There was no breaking-away observed, and the deflected angle was regarded as 0° because the colliding vehicle ran alongside the barrier. The testing vehicle stopped after 35.6m from

the point of impact.

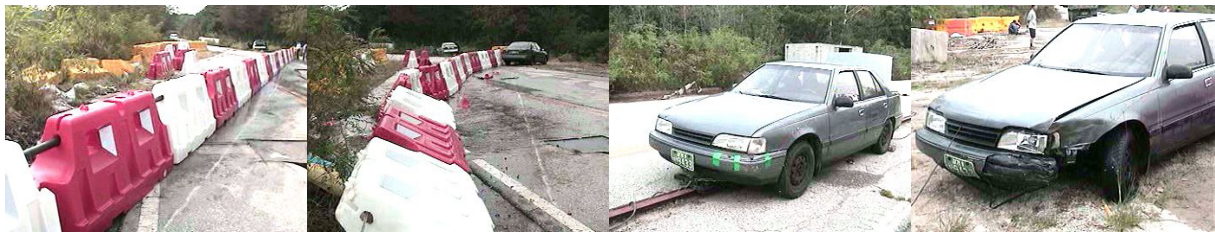
Figure 4. The testing vehicle and barrier before and after the collision test - Guard Box

Likewise for the guard box, the colliding vehicle did not indicate any possibility of breaking away, and the deflected angle was regarded as 0° for the same reason that it ran just alongside the barrier. The testing vehicle came to stop after running 28.7m from the impact point.
