# How Japan's Bullet Trains Survived the 2011 Great Tohoku Earthquake

**Abstract:** This paper assesses the consequences of the March 2011 Great Tohoku Earthquake in Japan in terms of the performance of the earthquake countermeasures deployed on Shinkansen, the Japanese high speed railway network (also known as the 'Bullet Train') so far. The survival of the Shinkansen trains is markedly an example of how technology made the difference.

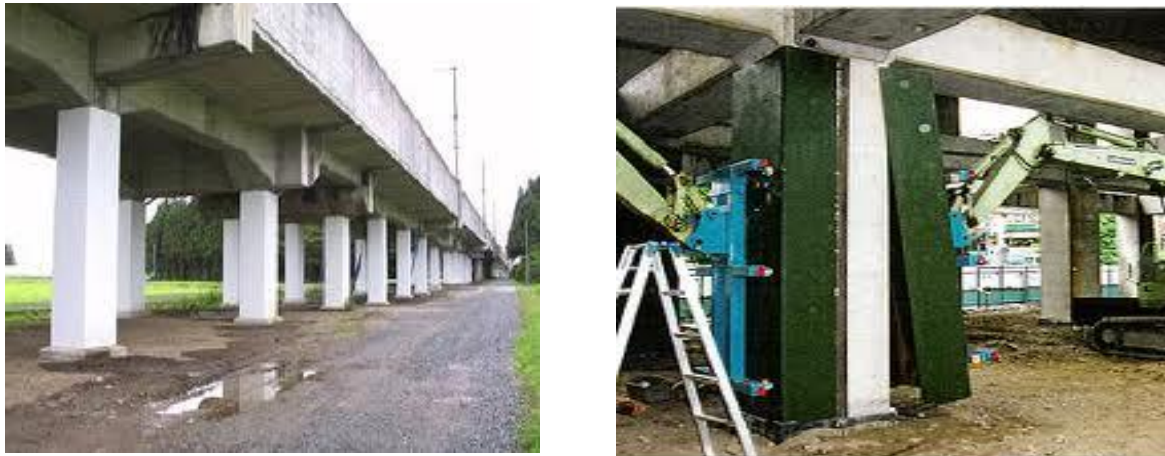
Figure 1. Viaduct Column Reinforcement

The structure of the Tohoku Shinkansen is comprised of continuous double-track viaducts, not of embankments as most conventional railway lines in Japan do except for tunnels in mountainous parts of the line. In Japan, earthquake-resistant construction standards were introduced in full-scale shortly after the Great Kanto Earthquake of 1923 and also have been revised successively up to today based on the lessons learnt from past damage cases. Especially in response to the Great Hanshin Earthquake of 1995, which destroyed many railway viaducts and revealed the fragile nature of the conventional reinforced concrete viaduct columns against horizontal displacement caused by earthquake shear force, the country's rail operators rapidly took actions of anti-seismic reinforcement of viaduct columns.

JR East had already completed the reinforcement works on the most vulnerable viaducts within its areas before the 2004 Chuetsu Earthquake. In this earthquake case, a Joetsu Shinkansen train running at a speed of some 200km/h was derailed due to the strong quake

motion but made a successful ‘soft landing’ without deviating and flipping from the roadbed. Nobody on board was killed nor injured thanks to the the anti-seismic reinforcement which had

been justly completed to the viaduct on which the train was derailed. It was quite possible that the derailment would be more devastating if the reinforcement had not been completed.

Learning lessons from the 2004 Chuetsu earthquake, JR East accelerated the progress of the anti-seismic reinforcement of the viaducts of the Tohoku Shinkansen, which is believed to be exposed to higher seismic hazard than those of the Joetsu Shinkansen, and completed it by 2008.

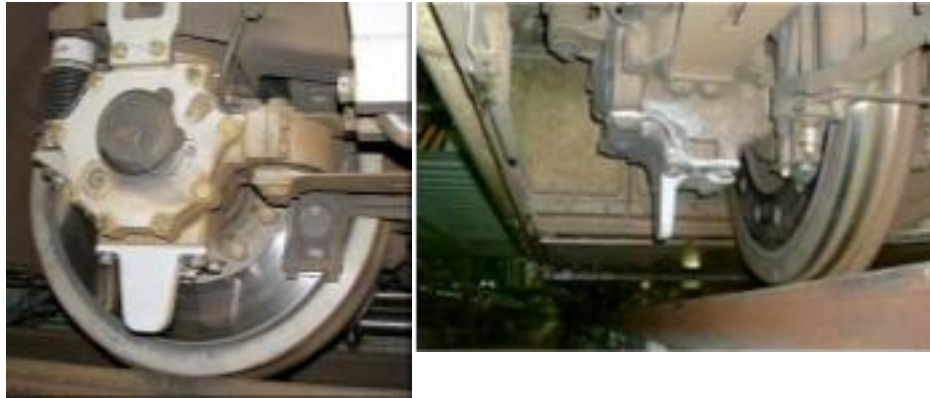
Figure 3. The Anti-straying Wheel Guide Mechanism

Based on the lessons learned from the derailment case in the 2004 Chuetsu Earthquake, JR East started to install the newly developed anti-straying wheel guide mechanism to all Shinkansen cars in 2006 and completed it in 2008.

On the day of the quake, at 2:47 PM, a seismometer at Cape Kinkazan in Miyagi Prefecture 50 kilometers from the tracks detected ground acceleration of 120 gals, which is the benchmark for stopping train operations. (This was S-wave detection. Later investigation made it clear that the P-wave detection failed due to an unusually slow oscillation growth pattern attributed to the exceedingly gigantic magnitude of the earthquake. ) The emergency brakes were then automatically applied to all 33 trains on the tracks to slow down. The seismometer at Sendai Station recorded the biggest tremors. The railway operator found that the first tremor occurred 9 to 12 seconds after 2 trains near Sendai slammed on the brakes. The strongest tremor came one minute and 10 seconds later. Only one train, running under test without passengers, derailed that day, but thanks to the above-mentioned anti-straying wheel guide mechanism, without falling from the roadbed .

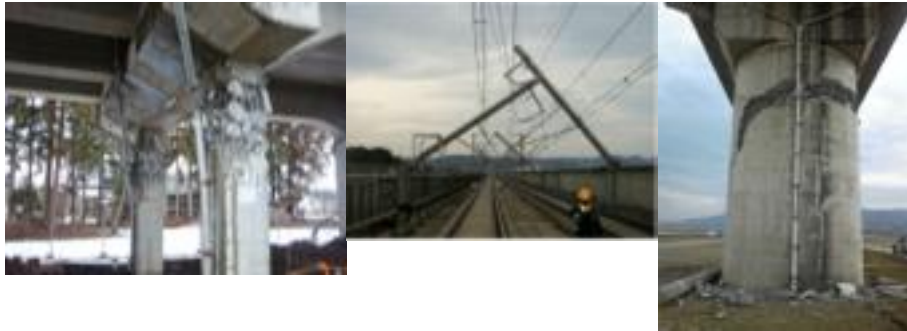
Figure 4: Physical Damages on the Shinkansen Structures

The SEWS and reinforcement works couldn't, however, save the railways from avoiding any damage whatsoever. Viaduct columns escaped from collapsing proving the effectiveness of the reinforcement works. But tracks were displaced and electrification masts were broken, leaning or cracked in many places.

In spite of these damages, Shinkansen trains re-started operations only 49 days after the earthquake. Around 8,500 engineers worked round the clock - repairing viaducts, bridges, tunnels, tracks, points, electrification masts and train stations - in order for the service to resume in time for the spring holiday season at the beginning of May. One reason for the early recovery was obviously that the damage in the structures was limited because of strengthening measures based on former earthquakes.
