**ROAD BLOCKAGE IN AN AREA AFFECTED
BY THE GREAT HANSHIN-AWAJI EARTHQUAKE
AND INFLUENCE OF BLOCKAGE ON TRAFFIC FLOW**

–The study area: Eastern part of Higashinada-ku,
Kobe City, Hyogo Prefecture, Japan

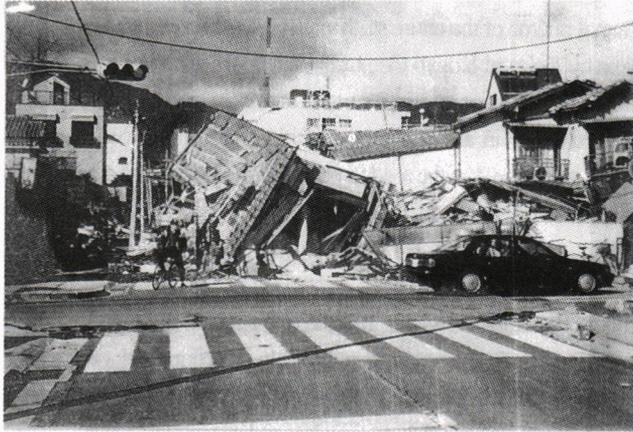
Photo 1. Local Distributor Road Blocked by Topped Houses (road width :12m)

examined the aerial photos of the entire study area (1:4000 scale, January 17, 1995; and 1:5000 scale, January 18, taken by Kokusai Kogyo Co., Ltd.). Where these photos were insufficient, we walked the area and conducted a resident hearing survey to obtain more detailed data. Road divisions we surveyed numbered 1,711 in all. The extent of blockage to the road was divided into four levels depending on the passableness of the road to pedestrians/bicycles and automobiles, as shown in Fig. 5. Photo 1 (road width 12 m), Photo 2 (6 m), and Photo 3 (4 m) each show the extent of blockage to the roads.

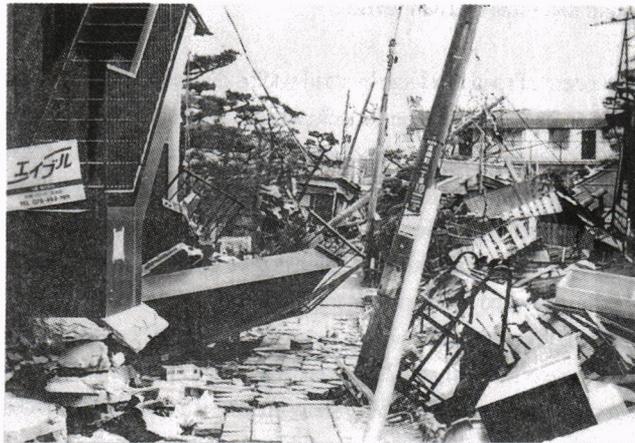
Photo 3. Residential Road Blocked by Topped Fences and Houses that Lined the Street (road width :4m)
