EXAMINING THE FACTORS RESPONSIBLE FOR THE REAR-END COLLISION AT THE MERGING SECTION OF THE GRADE SEPARATED CROSSING

Key Words: traffic accident, grade separated crossing, rear-end collision

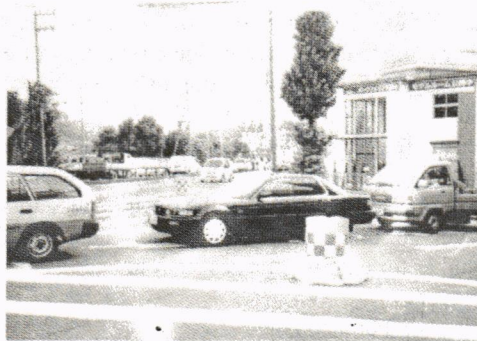
Figure-2 Overview of study area

Lack of the lane for acceleration

To construct a merging section, it is required to make the lane for the acceleration of the vehicle that merge into the main stream to catch up the speed of the vehicle that runs in the main stream. However, there is no lane for acceleration at this area because this road was constructed as a renewal by-pass route of the existing lane. Acquiring land for this lane was very difficult, primarily due to holding of the land by multiple owners. Due to this, the length of acceleration lane was shorten than the desired one. Therefore driver who wants to merge into the main stream should take a longer headway to merge compared to the case with the acceleration lane because it takes longer time to speed up. This longer headway will generate the variety of the decision to merge creating a highly accident-prone situation.

Location of stop-line

When a driver who wants to merge into the main stream comes to the merging section, driver firstly stop at the stop-line. In this place, the location of stop-line is a little far from the main stream, and this makes driver to go forward until the place where merging vehicle will not disturb the vehicle running in the main stream. This is not good way of merging into the main stream because driver sometime stops two times and this will make another driver behind the queue misunderstood that forward vehicle had started to merge at the first start. By the way, it could be thought that police is eager to put the stop-line apart from the main stream because of the lack of acceleration lane. Driver tend to keep a longer view toward the main stream because of the difficulty of merging while it is possible for the driver in the branch lane to check the main stream from the stop-line.

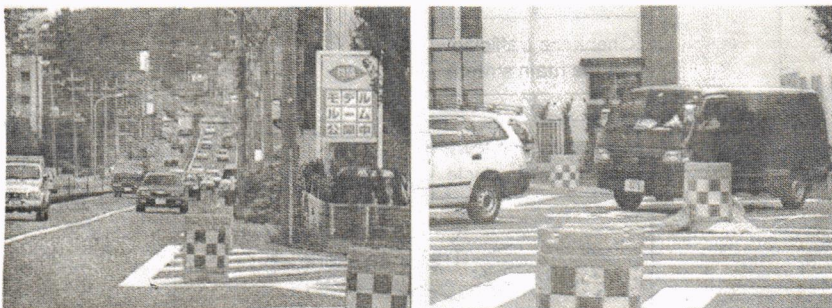
Video survey was conducted on November 6th in 2000 over this area. Two video cameras were used to get the characteristics of traffic flow and the behavior of the driver. One camera is set to catch the headway and travel speed in the main stream. And the other one was set to catch the action of second vehicle in the queue. From this video observation, the adequate gap of front car, the timing of the winker, position of the decision, and other relevant pieces of information were obtained.

Figure-5 View from the video camera

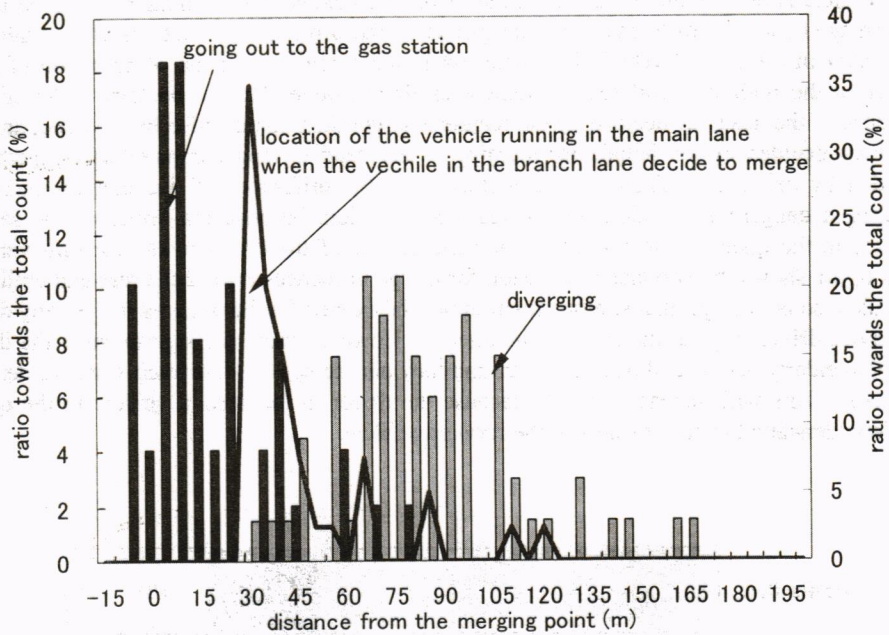
To understand the influence of the gas station located near by this section, the position that the driver start to show the winker was measured from the video data. Figure-7 shows the position that the driver start to show the winker in each for diverging and going out to the gas station, and also the position that the vehicle in the queue start to merge when the vehicle in the main stream starts to diverge. From this figure, it is found that there are some overlap area of the winker appearance for both diverging and going out to the gas station, and there is some vehicle merge into the main stream around this overlapped area. This shows the danger for merging. If the driver in the first vehicle in the queue that start to merge feel impossible at that time for merging and the driver in the second vehicle feel that the front vehicle will merge into the main stream, the ratio of hazard will increase, because the situation that the driver in the first vehicle will stop for merging will tend to happen.

From this figure, it is possible to calculate the ratio of overlapped area. And multiplying the ratio of merging for the driver in the queue, it is able to show the hazard for the rear-end collision caused by the gas station beside the merging area.

Figure-7 Position that the driver start to show the winker

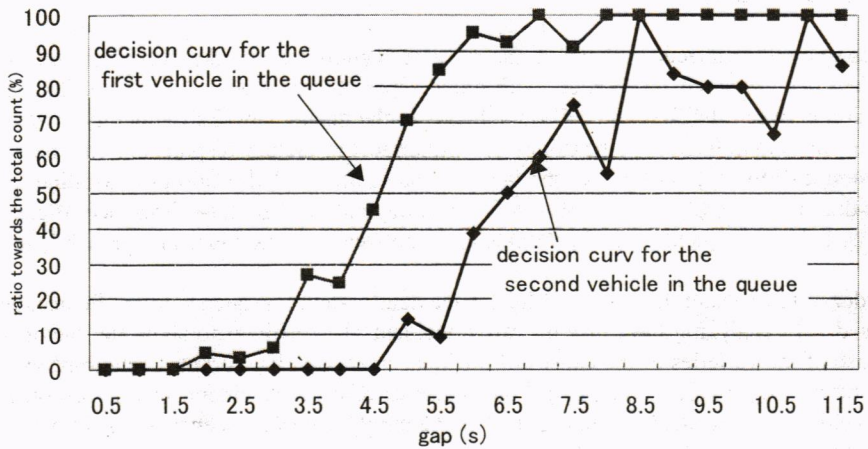
From the video data, it is found that some vehicle in the second position in the queue merge into the main stream simultaneously as the first vehicle. This phenomenon shows the danger case for the rear-end collision, because there are few margin for the driver of the second vehicle in the queue. At this time, it takes times to stop when second driver realizes the break of the first vehicle in the queue, because the driver of the second vehicle is accelerating for merging. Therefore it is important to understand the current characteristic of merging for both first and second vehicle in the queue. Figure-8 shows the relationship between the gap, that is calculated by the headway and the speed of each vehicle in the main stream in time, and the percentage of merge into the main stream in each first and second vehicle in the queue. From this figure, it is found that there is a person not to merge, nevertheless there is a long gap, and the line, that shows the merge of the second vehicle, shifts to the right because of the needs for the longer gap in merging. This line will be shifted to the right and left by the characteristic of the driver such as female driver, novice driver or elderly driver. By comparing with these lines, hazard for the merging simultaneously will be clarified. And also, it is possible to evaluate the hazard for all merging section by comparing among the other merging section. Furthermore, the degree of hazard can be computed by multiplying the percentage of "stop" for the first vehicle and the percentage of "go" for the second vehicle.

Figure-8 Decision curve for the first and second vehicle in the queue
