Analysis of the Pedestrian Infrastructure and Pedestrian Volume at Setiawangsa LRT Station

Nik Nurul 'Aziemah NIK OTHMAN^a, Abdul Azeez KADAR HAMSA^b

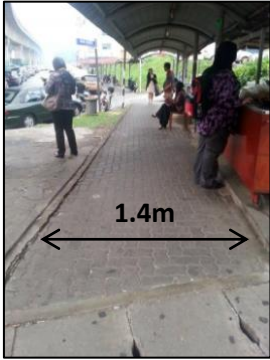
<p>1.4m</p> <p>Walkways located at Point 1</p>	<p>1.6 meters</p>

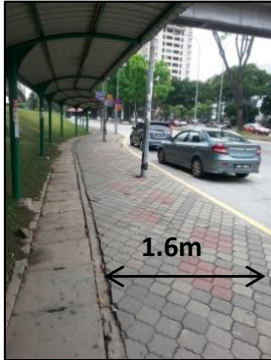
<p>1.6m</p> <p>Walkways are located at Point 2 and 3</p>	<p>2.2meters</p>

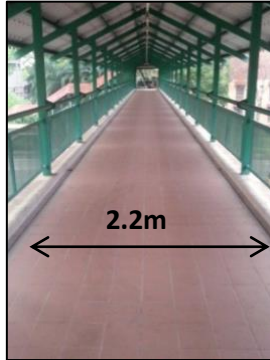
<p>2.2m</p> <p>Walkways is located at Point 4 which is a pedestrian bridge</p>
	<p>3.6 meters</p>

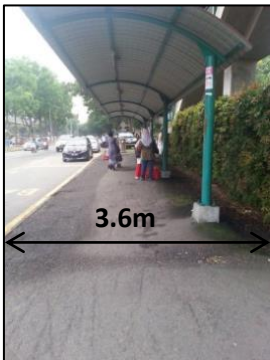
<p>3.6m</p> <p>Walkways is located at Point 5</p>	<p>1.7 meters</p>

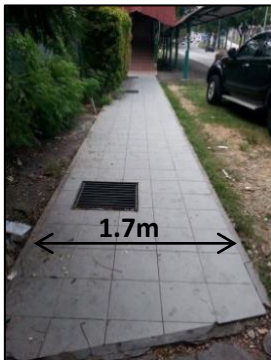
<p>1.7m</p> <p>Walkways located at Point 6</p>	<p>2.1 meters</p>

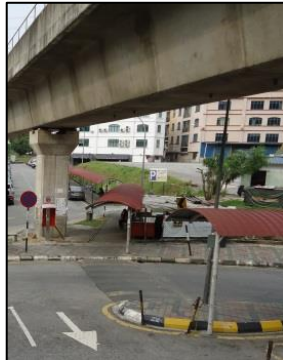
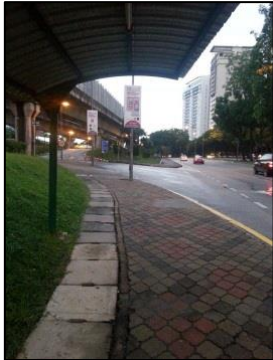
Walkways at Point 1 connecting the pedestrians to the parking area at the other side of the road.	Walkways at Point 3 is continuous to the entrance of Setiawangsa LRT station.	The walkway at Point 5 connects pedestrian to residential area, Kg. Warisan.
	Direct connection between activity

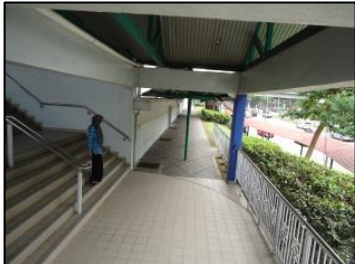
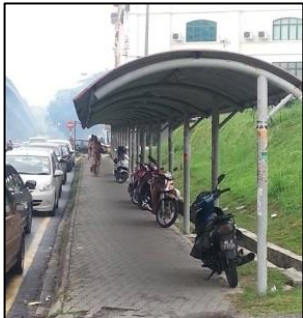
Walkways at Point 2, Point 3 and Point 4, provide a direct connection between activities. For example, it connects pedestrians straight to the Setiawangsa LRT station.	Walkways at Point 1 provides a direct connection to the commercial area. Unfortunately, there were many motorcycles parked along the pedestrian walkways.

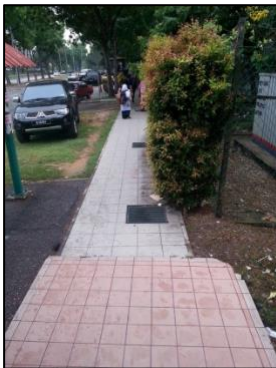
Walkways at Point 1 provided with a non-slippery material which is known as interlocking pavers.	Point 2 and Point 3 were also provided with non-slippery material for the pedestrian walkways, interlocking pavers.	Point 4, which is the pedestrian bridge was provided with tiles for its surface.

Pedestrian walkway at Point 5 was also provided with non-slippery material which is tar. However, there was damage to the walkways which may harm the pedestrians, especially children.	Point 6 was provided with tiles for the surface material. During the survey, it was raining heavily which caused the tiles to be wet and made the walkways slippery for pedestrians.	Pedestrian walkway at Point 7 was provided with non-slippery material which is also known as tar.

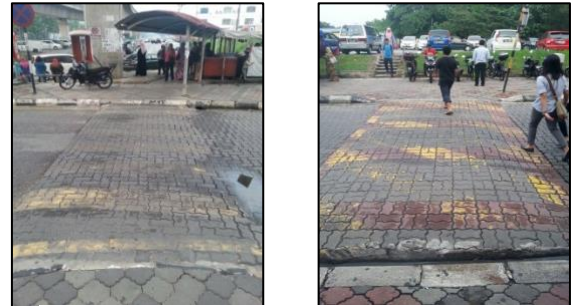
Figure 3. Zebra crossing

A zebra crossing was provided at two locations near Setiawangsa LRT station. However, the colour of the zebra crossing was faded and as a result makes it less obvious to the pedestrians. Furthermore, only one of the zebra crossings was provided with a signage indicating its location to the drivers of the moving vehicles.

Two types of crosswalks were identified namely zebra crossing and elevated pedestrian crossing. Figure 3 illustrates the details of both zebra and elevated pedestrian crossing near Setiawangsa LRT station.

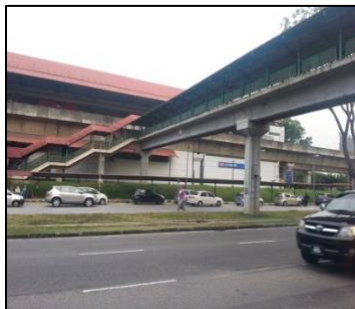
Figure 4. Pedestrian bridge crossing

Elevated pedestrian crossings are usually provided at locations with a high volume of traffic and heavy pedestrian crossings such as schools, shopping areas, train stations etc. for the pedestrians to cross from one side of the road to another side safely. One elevated pedestrian crossing is provided at Setiawangsa station to ease the movements of pedestrians.

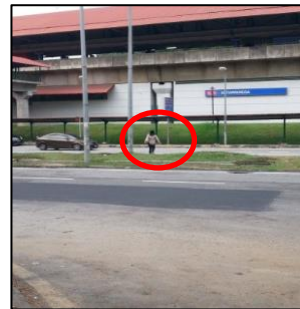
Figure 5. Pedestrian crossing the road

Surprisingly, many pedestrians were observed not using the elevated crossing to cross from one side of the road to the other side connecting the LRT station. Instead, they were seen crossing the road at the road level without using the pedestrian elevated crossing. It was the case even with pedestrians with children. Figure 5 shows a pedestrian crossing the road at the road level instead of using a pedestrian elevated crossing.
