Identification of Black Spots for Pedestrian Accident in Yangon

Nuzin AUNG HTAY ^a, Kyaing ^b, Nanda KYAW WIN ^c, Thurain AUNG KYAW ^d

^{a,b,c,d} *Yangon Technological University, Yangon, Myanmar*

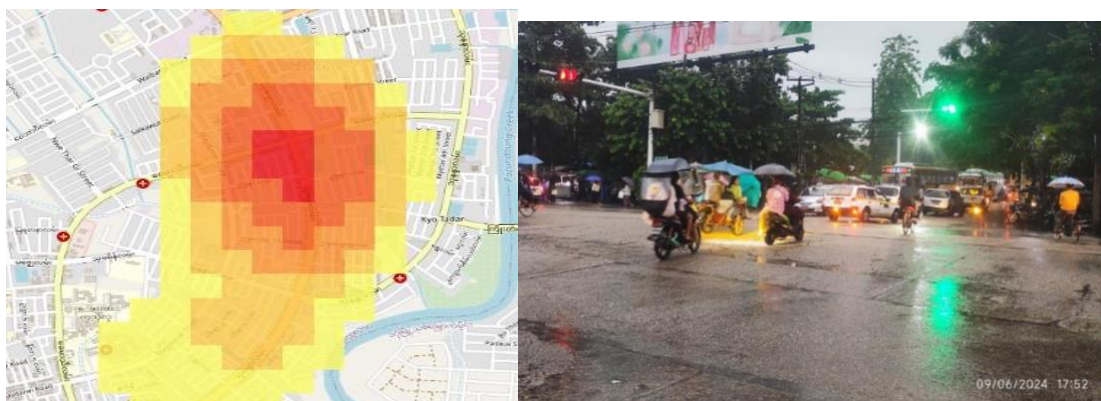
This blackspot, rank 1, is on Thu Damar Road, around Kan Thar Yar Park, North Okkalapa Township. In this location There is 1 accident with slightly injured individuals, 8 accidents with seriously injured individuals, and 6 fatal accidents. The Severity Index of 55 reflects the weighted severity of accidents at this location, with fatalities and serious injuries contributing significantly to the high SI.

This location is the highest-ranked black spot based on the Severity Index, indicating it is the most critical area for intervention due to the high severity of accidents. Figure 3 shows the black spot location (rank 1).

Figure 6. Black Spot Location (Rank 1)

Thu Damar Road is arterial road is designed to handle high volumes of traffic and facilitate long-distance travel. They connect different parts of a city or region and are crucial for efficient traffic flow. The road accommodates various types of vehicles, including cars, trucks, buses, and possibly bicycles. Mixed traffic can lead to complex interactions and increased accident risk.

The road supports bidirectional travel with separate lanes for each direction. There are three lanes in each direction, which helps manage high traffic volumes but can also contribute to higher speeds and potential conflict.

There are no designated pedestrian crossing signs, making it difficult for pedestrians to safely cross the road. There are no marked pedestrian crossings on the road, further increasing the risk for pedestrian. The intersection where the black spot is located is controlled, likely by traffic signals or signs, which manages vehicle flow but does not address pedestrian needs. There is no dedicated pedestrian phase at the traffic signals, which means pedestrians do not have a specific time to cross safely.

To enhance safety, it is recommended to install pedestrian crossing signs and markings, improve lighting conditions, especially at night, consider adding pedestrian phases at traffic signals and address crowd management to reduce congestion and improve safety.

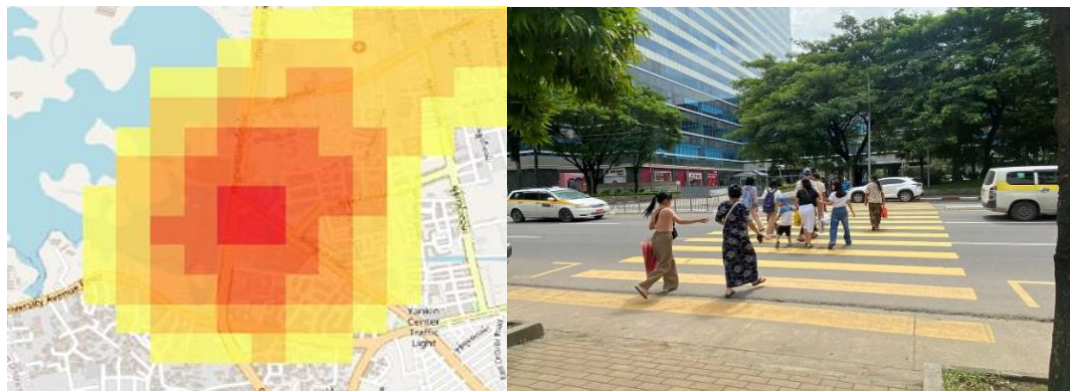
Kabar Aye Pagoda Road is major road and designed to handle high traffic volumes and provide important connections within a city or region. They are crucial for facilitating long-distance and high-speed travel. This mixed usage can lead to interactions that may increase the risk of accidents.

This road allows vehicles to travel in both directions, which supports bidirectional movement but requires careful management to prevent accidents. The road has three lanes in each direction, providing substantial capacity for handling high traffic volumes. However, the wide lanes can also contribute to higher speeds and potential conflicts.

Figure 7. Black Spot Location (Rank 2)

The pedestrian crossing signs are present, indicating designated points for pedestrians to cross the road safely. This helps in guiding pedestrians and improving their safety. The road features well-marked pedestrian crossings, which provide clear guidance for pedestrians and enhance safety at crossing points.

To enhance safety at this black spot, consider implementing to enhance street lighting to address visibility issues, especially at night, ensure that pedestrian crossings are well-maintained and consider adding additional crossing points if needed and implement speed control measures or traffic calming features to reduce the likelihood of high-speed collisions.

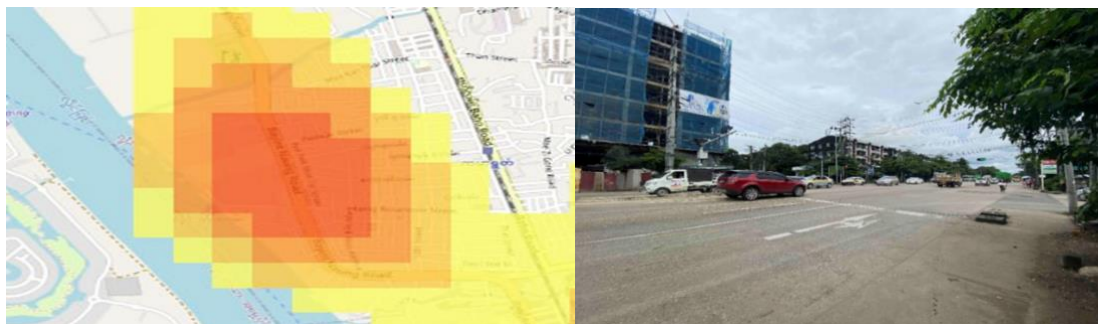
Figure 8. Black Spot Location (Rank 3)

Ba Yint Naung Road is arterial road and accommodates a variety of vehicle type. This mixed traffic usage can create complex interactions and increase the risk of accidents.

The road has lanes for traffic in both directions, allowing bidirectional travel. This configuration requires careful management to prevent accidents.

The road has three lanes in each direction, providing substantial capacity for handling high traffic volumes but also contributing to higher speeds and potential conflicts.

There are no designated signs indicating pedestrian crossing points, which may make it difficult for pedestrians to find safe places to cross the road. The road has pedestrian crossing markings, but they are faded and less visible, reducing their effectiveness in guiding pedestrians safely. The intersection is controlled by traffic signals or signs, which help manage vehicle flow but may not adequately address pedestrian needs. There is no dedicated pedestrian phase at the traffic signals, meaning pedestrians do not have a specific time to cross safely, contributing to increased risk.

To improve safety at this black spot, consider the improving of street lighting to increase visibility during night-time and reduce accidents related to poor lighting, refresh and clearly mark pedestrian crossings to make them more visible and effective and to add clear signage indicating pedestrian crossing points to guide pedestrians and enhance safety. And then implement dedicated pedestrian phases at traffic signals to provide safe crossing opportunities.
