# A Study on Laboratory Testing and Performance Evaluation Method for the Development of an Anti-dew Road Sign

Duk Geun YUN<sup>a</sup>, Jae Hong PARK<sup>b</sup>, Jung Gon SUNG<sup>c</sup>, Weon Eui KANG<sup>d</sup>

<sup>a,b,c,d</sup> Korea Institute of Construction Technology, Gyeonggi-Do, 411-712, KOREA

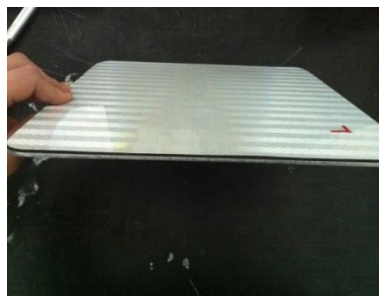
Here the specimen signs are divided into 2 types, being 1) basic types of signs where retro-reflective sheets are directly attached onto aluminum panels 2) Signs where urethane is attached onto aluminum signs, and retro-reflective sheets attached on top.

(a) Inserted-insulation layer road sign

(b) Normal road sign

Figure 4. Concept of road sign with insulation inserted which was used in the experiment  
**4.3 Test in the thermo hydrostat to generate dew**

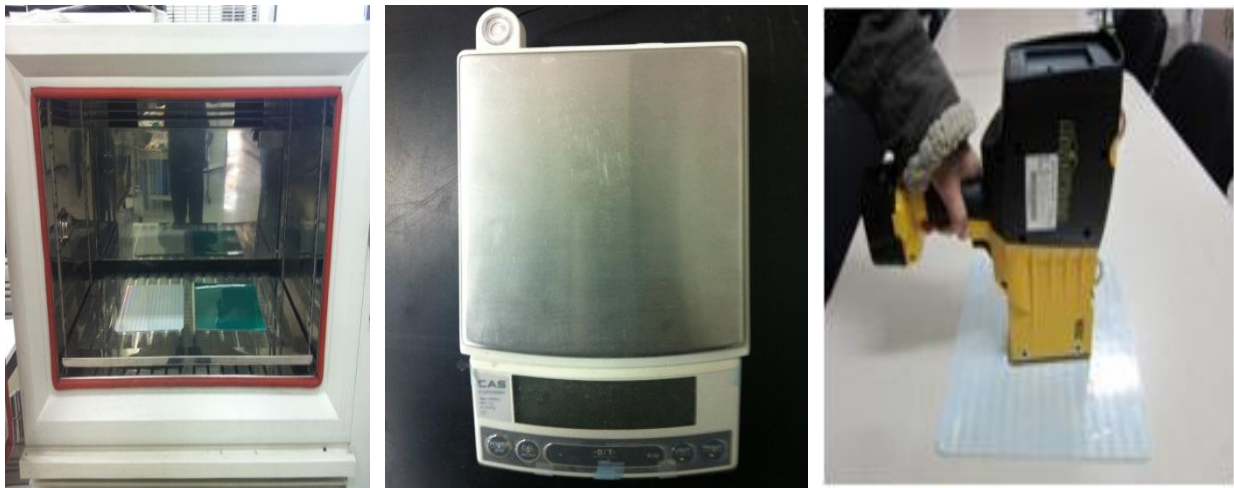
In order to generate dew on both the normal sign and insulated sign, they were simultaneously placed inside the thermo-hygrostat to implement the experiment.

The temperature change of the thermo hydrostat (relative humidity 100%) changed from 25°C to 5°C. The signs were left in the thermo-hygrostat for about 3-4 hours so that the signs adjusted to the initial temperature.

Figure 5. Equipment used for the experiment
