Recent Disaster Responses & Lessons Learned in EASTS Member Countries & Regions

Disaster Response and Adaptation in Rural Areas: The Case of the 2024 Noto Peninsula Earthquake

Daisuke Fukuda
The University of Tokyo

Overview of the Noto Peninsula Earthquake and Damage

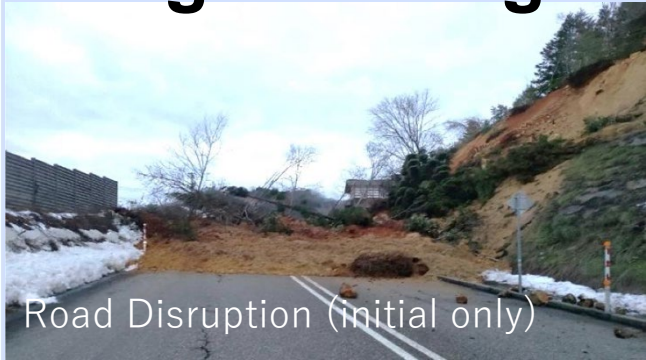
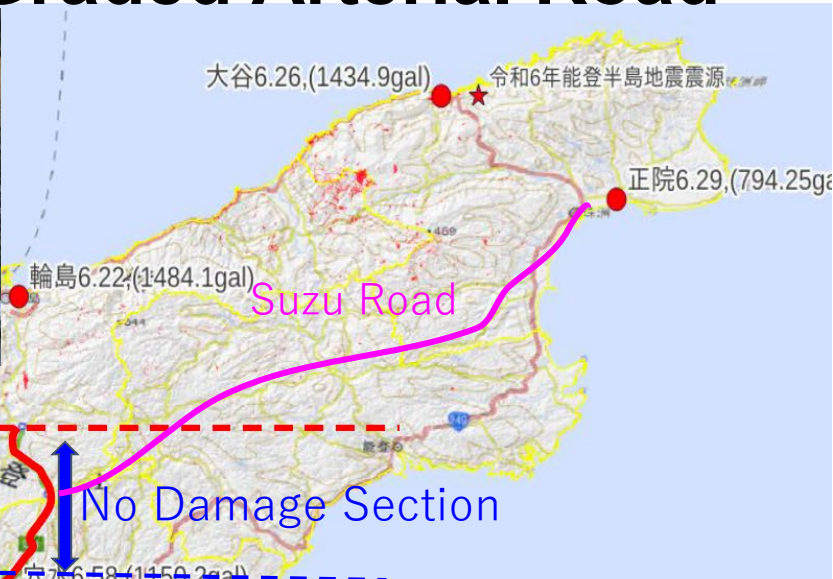
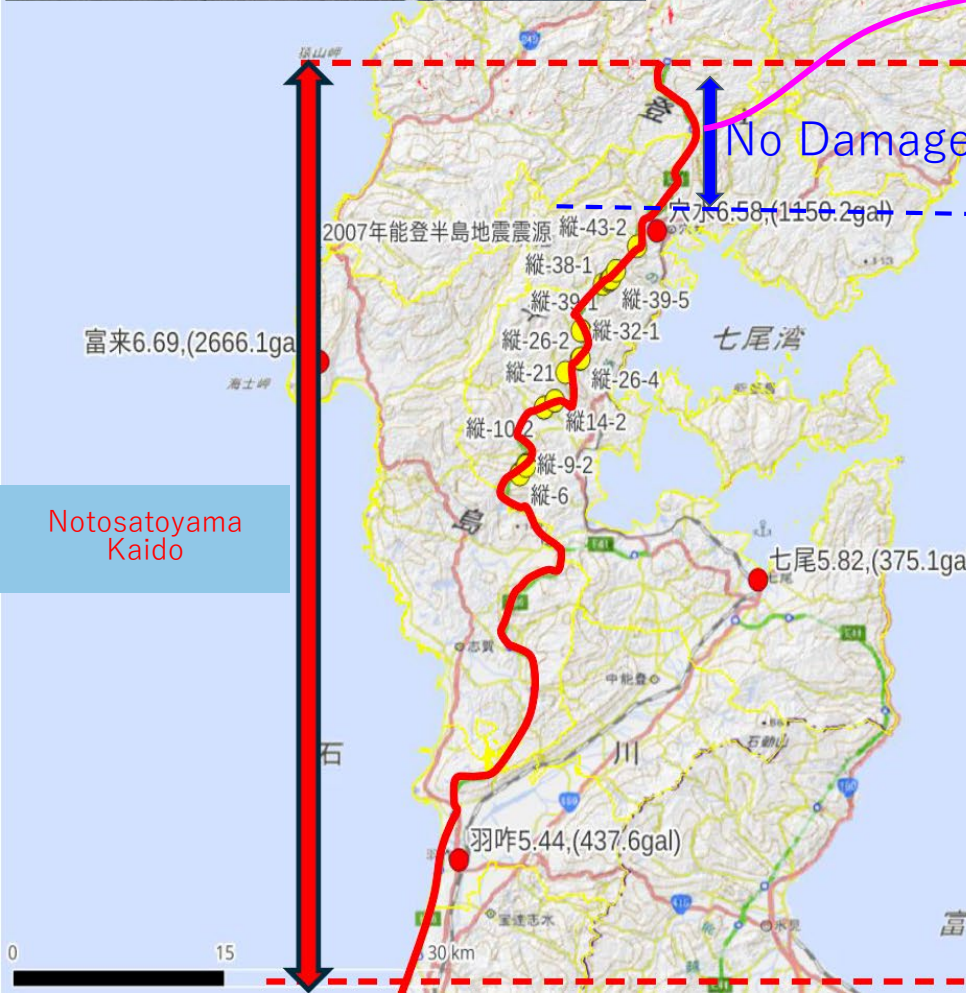
Damage to a High-Graded Arterial Road

Norisatoyama Kaido [High-Standard Arterial Highway].

Most of the section was constructed with embankments.

Damaged during the 2007 earthquake (intensity 6)

→ All of the 12 sites that were reinforced and restored at that time are safe this time (but adjacent sites were damaged).

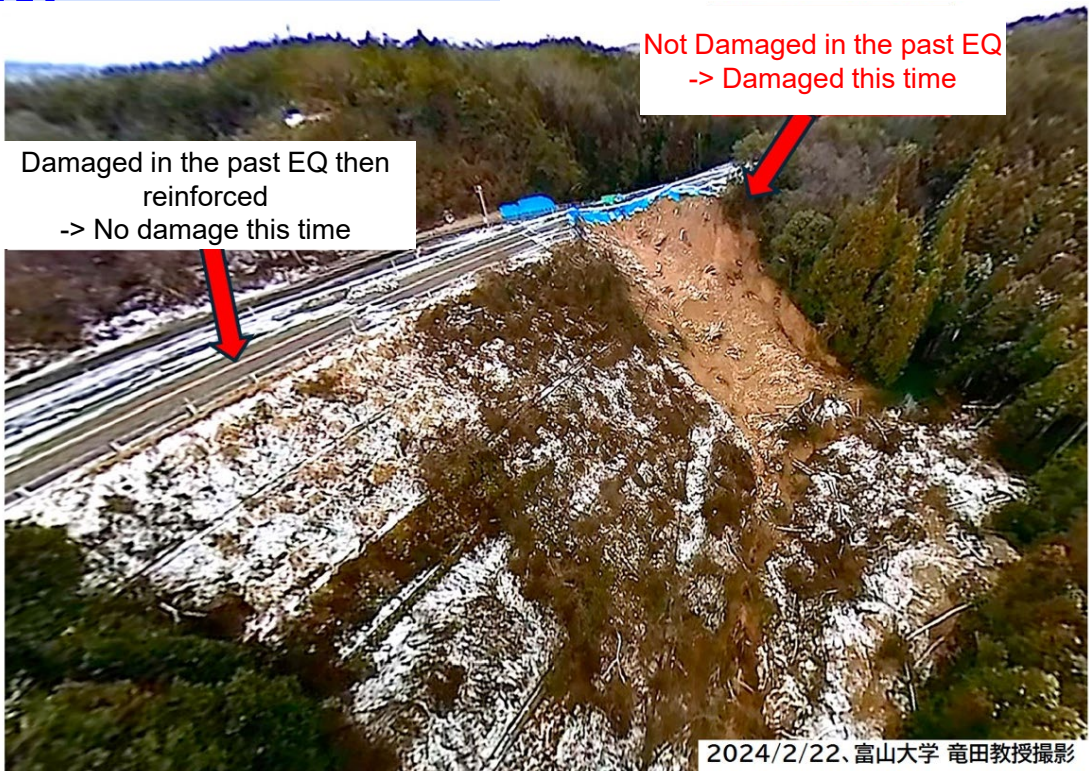
Disruptions due to slope collapse, etc., occurred in various locations along the outer sea side of National Highway #249, and Notosatoyama Kaido

Cracks in the roads are also very numerous.

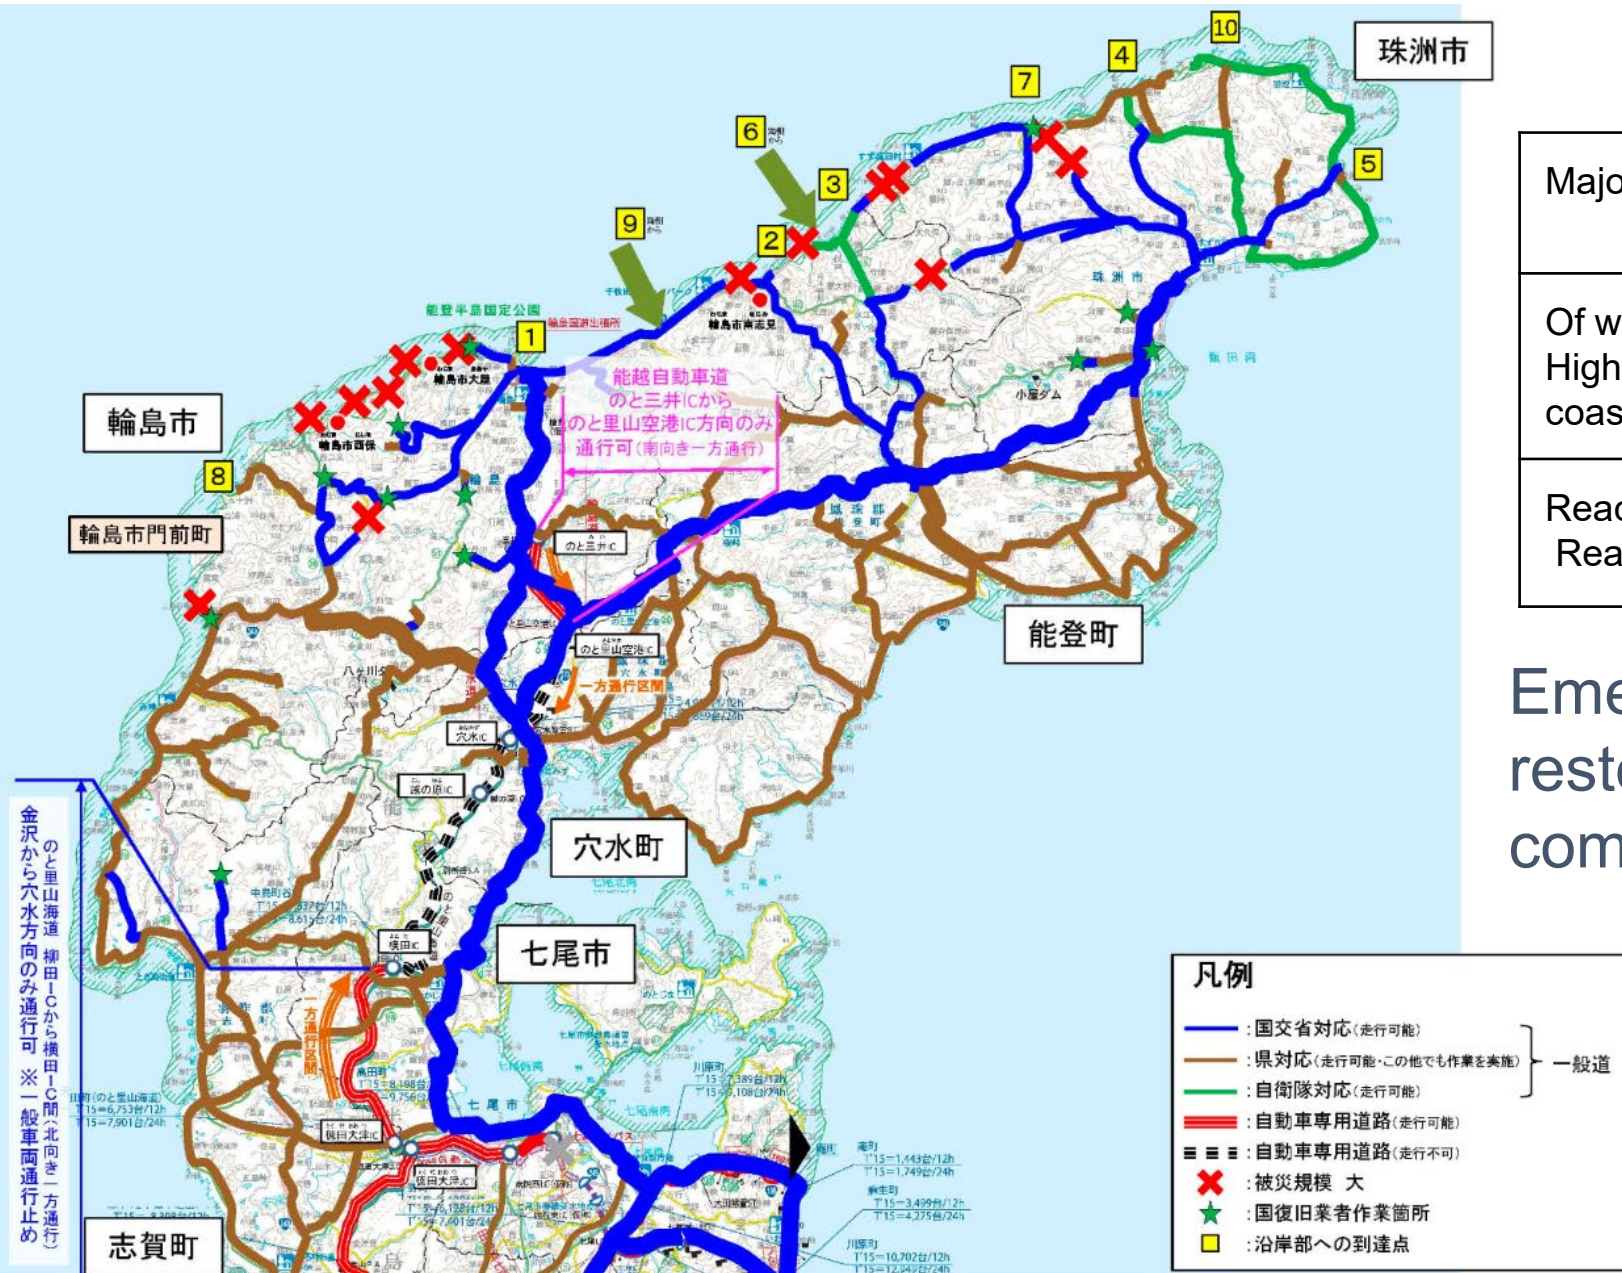
February 1

Major trunk roads	Approx. 90%
Of which, National Highway # 249 coastal area	Approx. 80%
Reaching the coast Reach	10 directions

Emergency restoration of comb-shaped NW

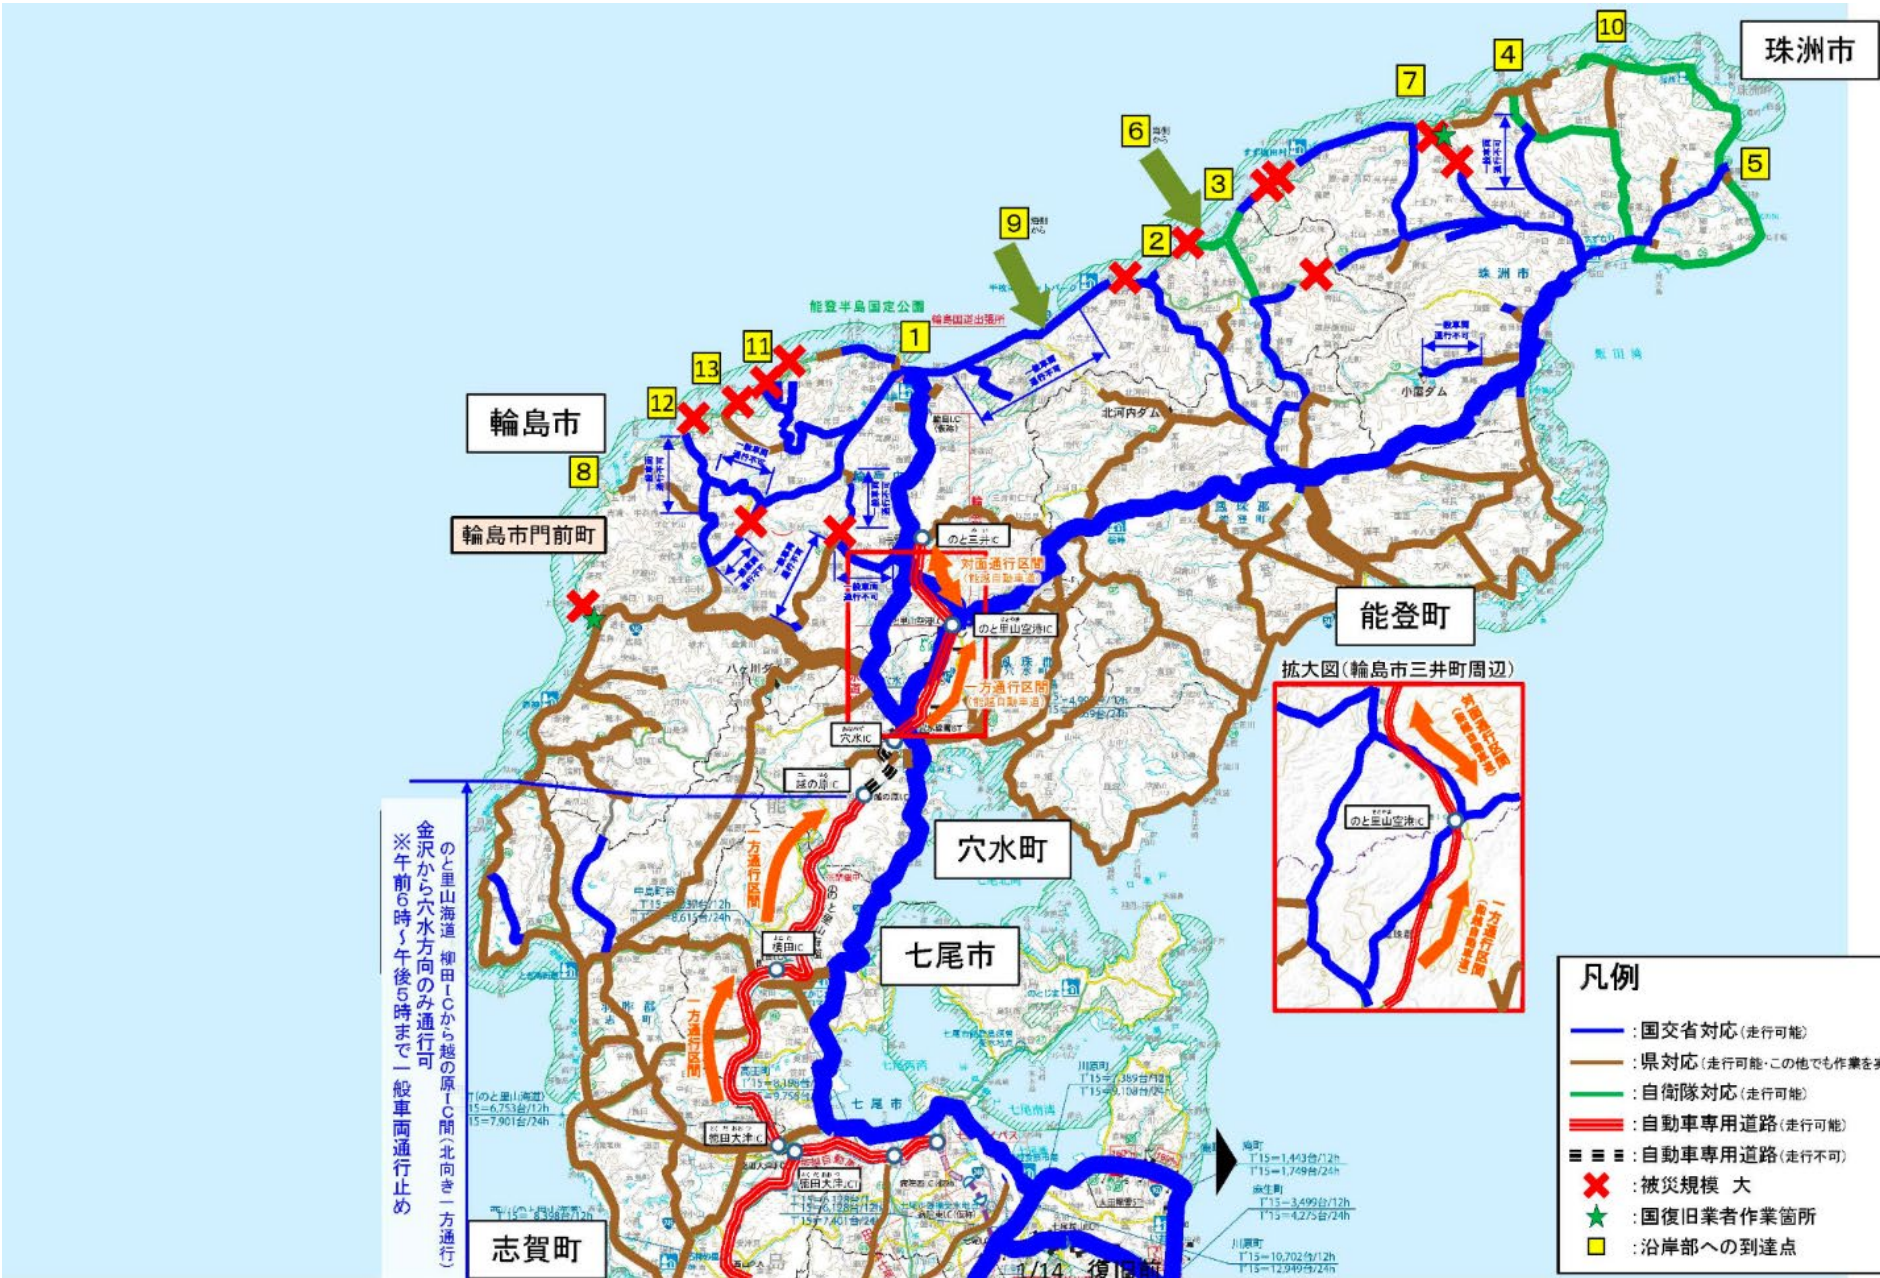
Major trunk roads	Approx. 90%
Of which, National Highway # 249 coastal area	Approx. 80%
Reaching the coast Reach	13 directions

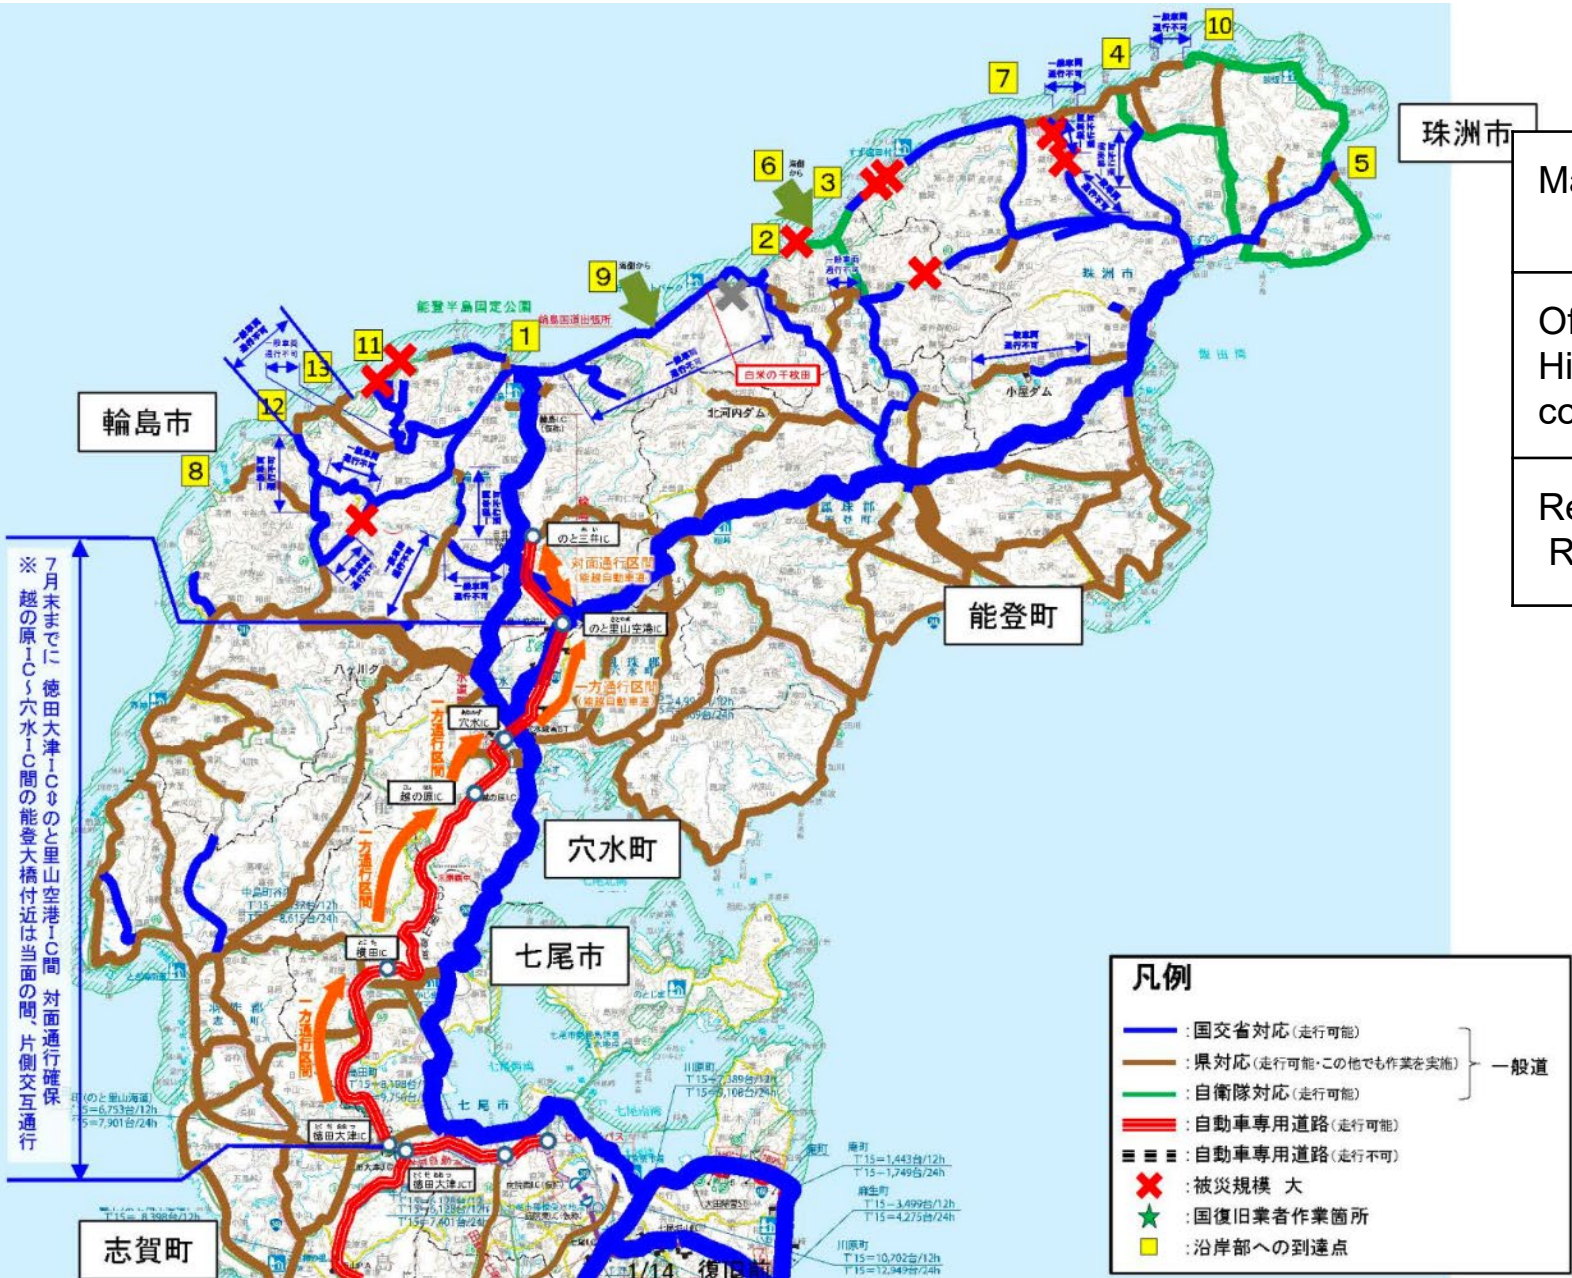
Major trunk roads	Approx. 90%
Of which, National Highway # 249 coastal area	Approx. 80%
Reaching the coast Reach	13 directions

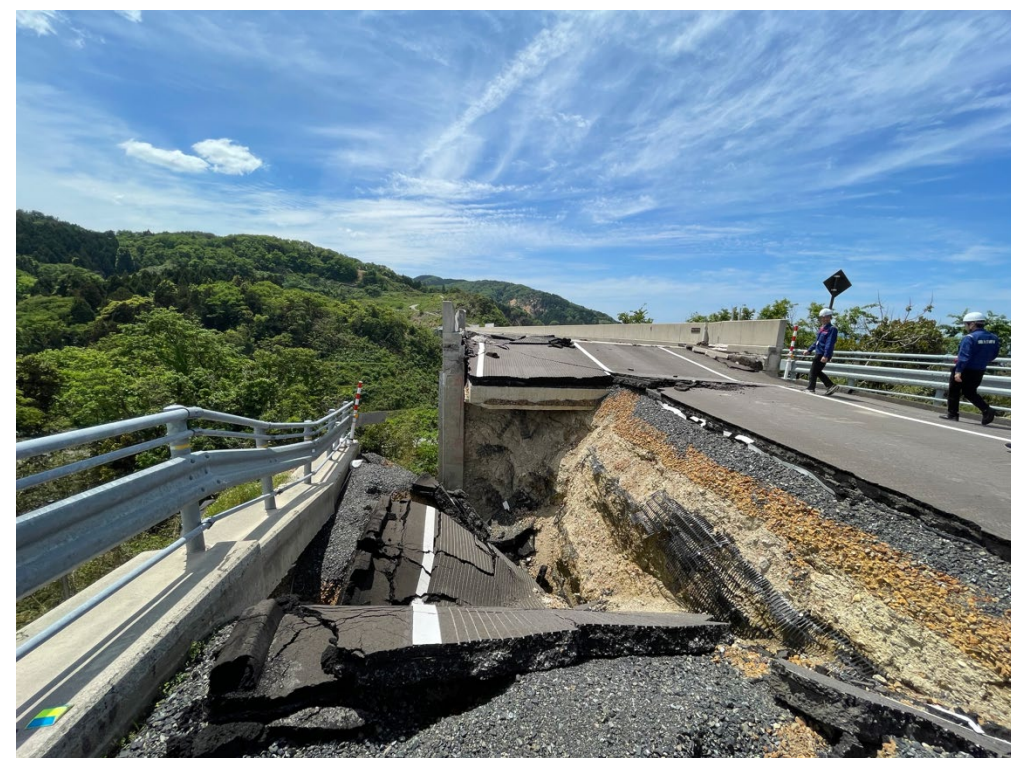
Route 249, Oya Loop Bridge (Suzu City, photo taken May 15)

Large skidding of the pier bearing section

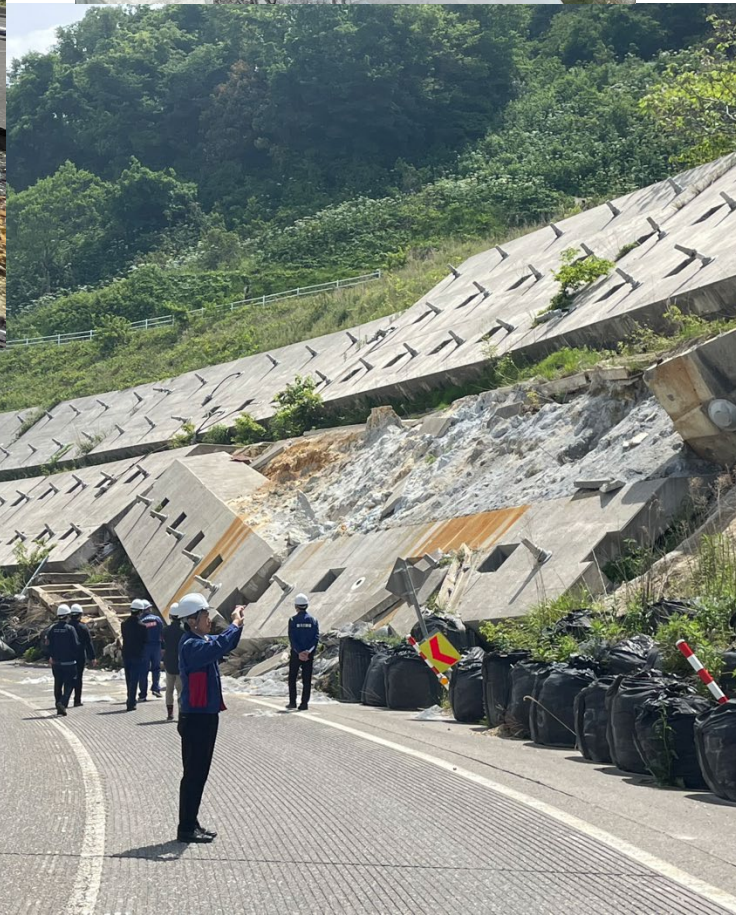
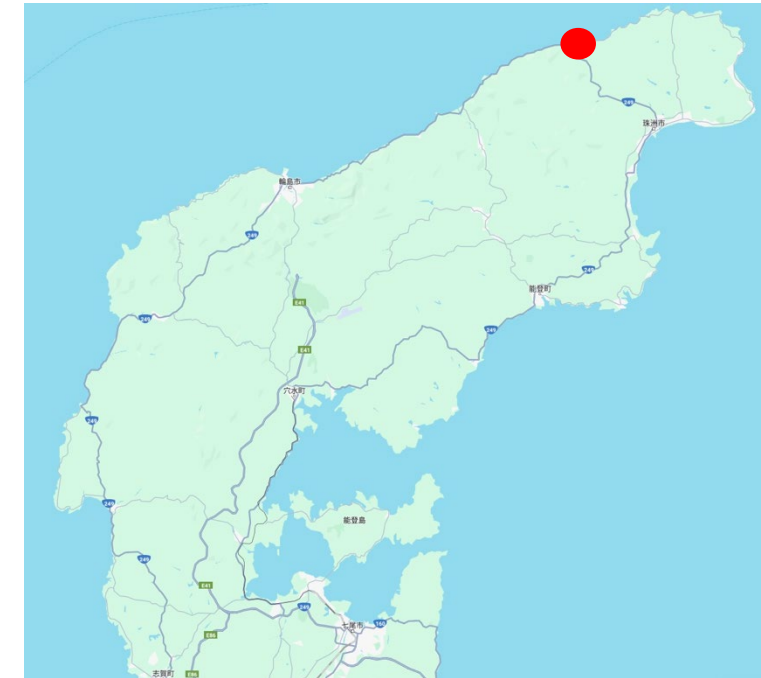
Large scale slope failure in the loop area

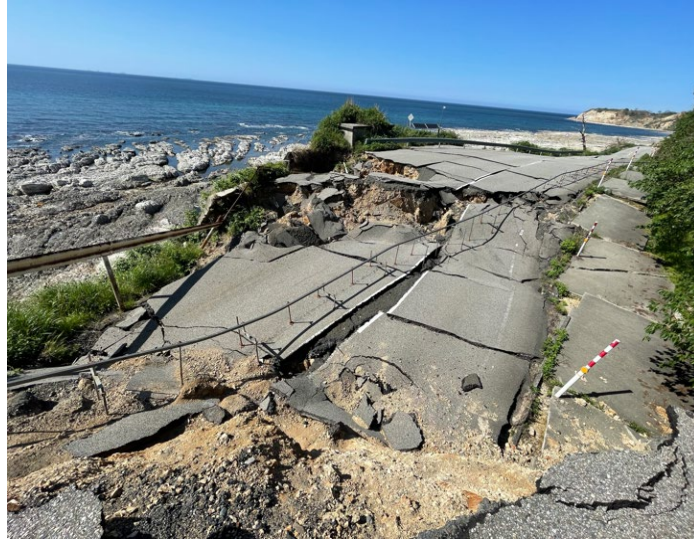
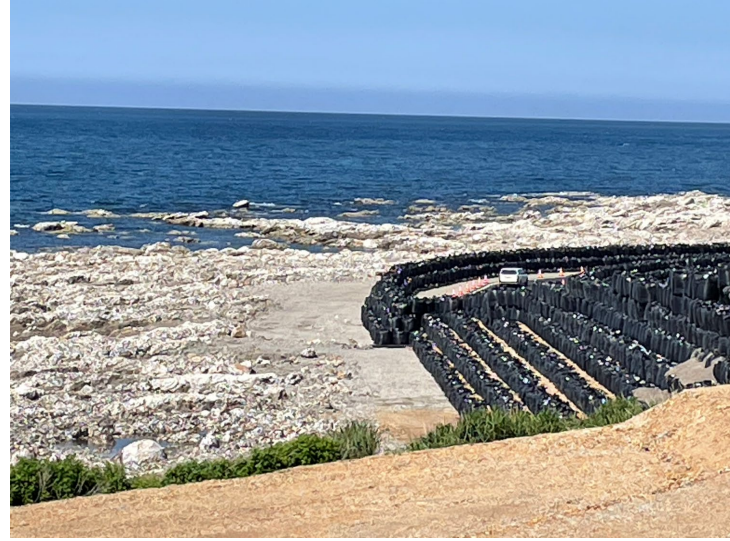
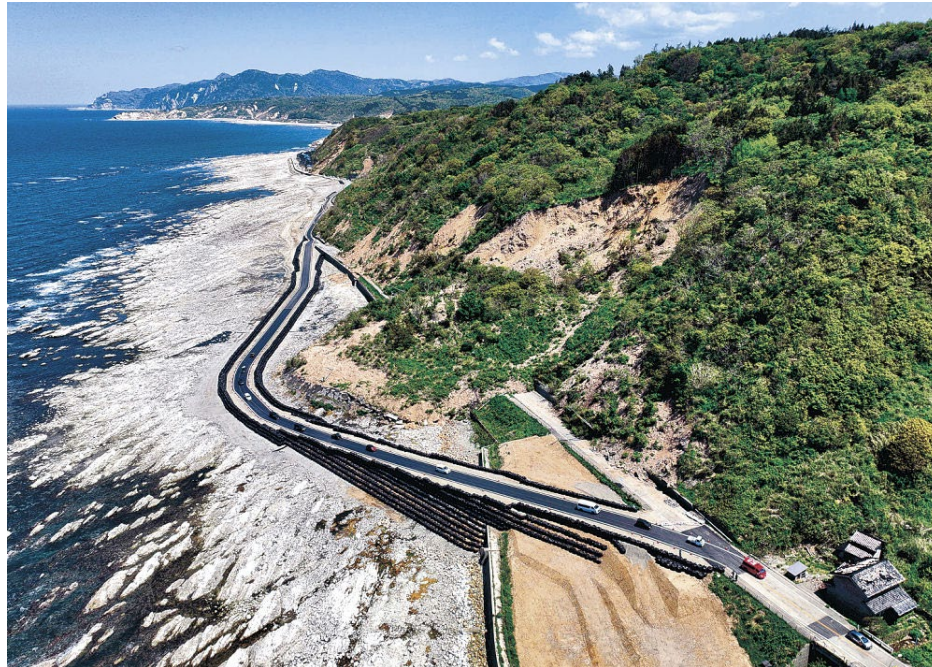
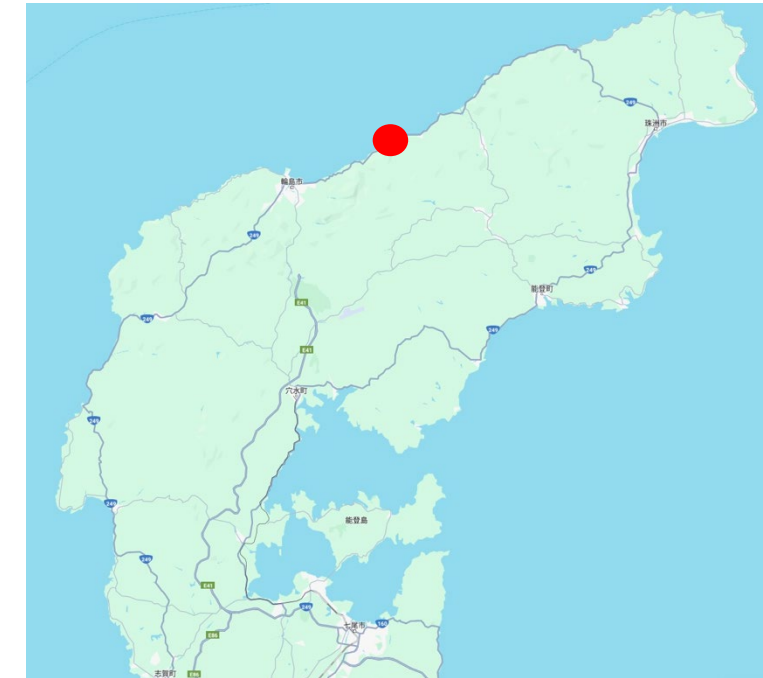
Route 249, near Senmaida Roadside Station (Suzu City, photo taken May 15)

Established an emergency road in the uplifted area.

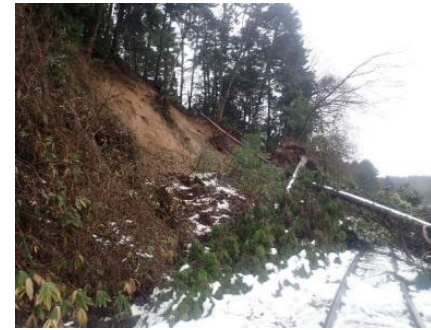
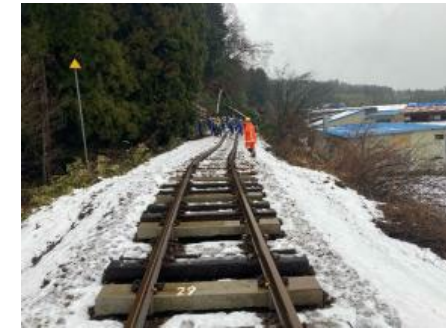
Noto Kashima - Anamizu (embankment subsidence)

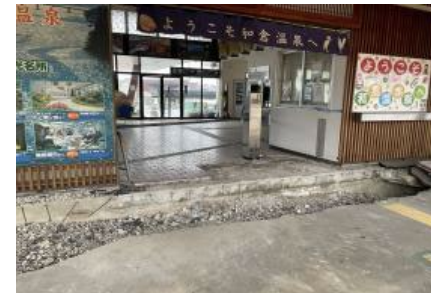
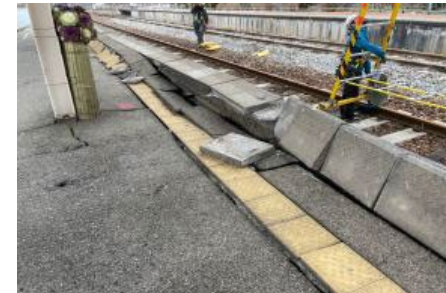
Wakura Spa St. (platform sinking etc.)

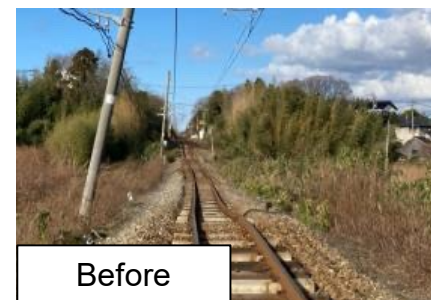
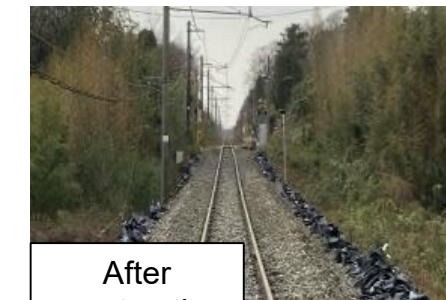
Shikinami - Minami Hakui (pole tilt, track displacement,)

Before construction

After construction

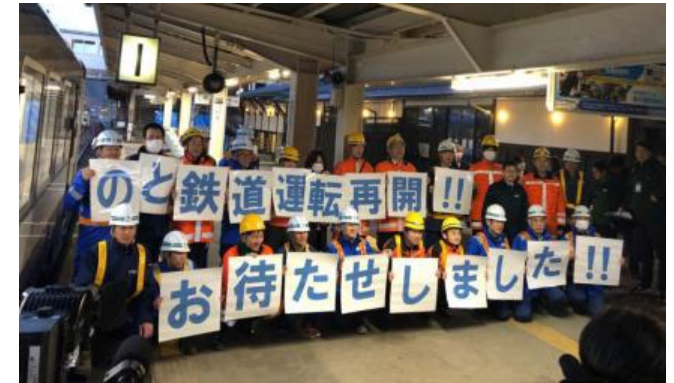
Apr. 13 at Noto Kashima St.

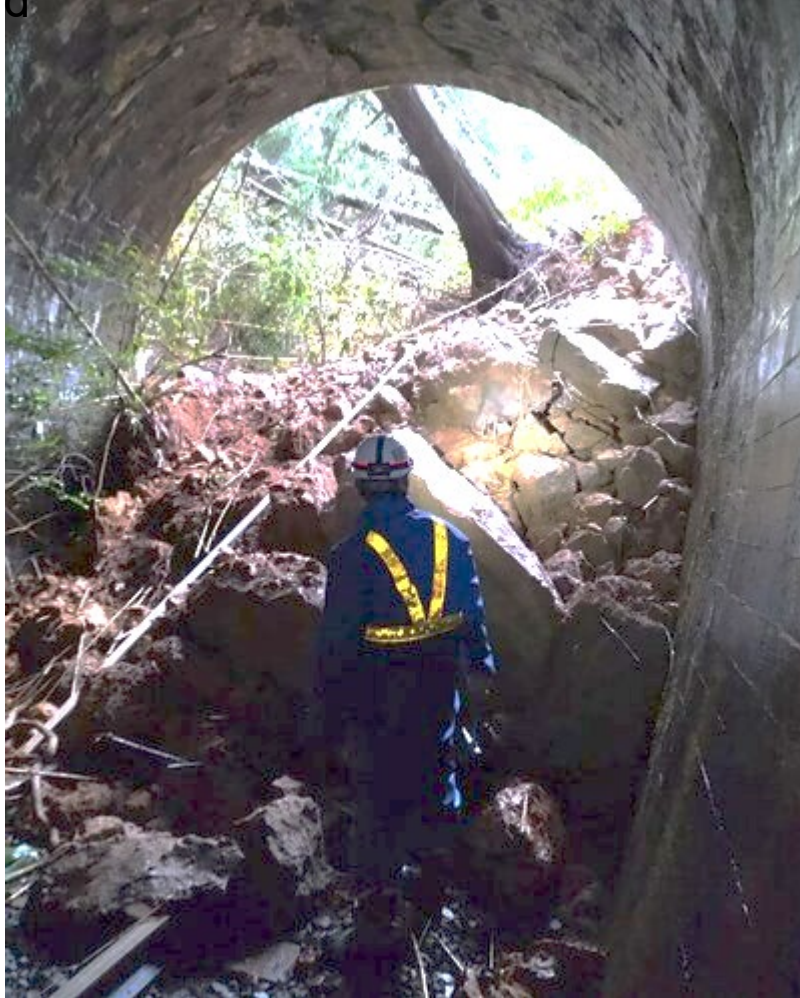
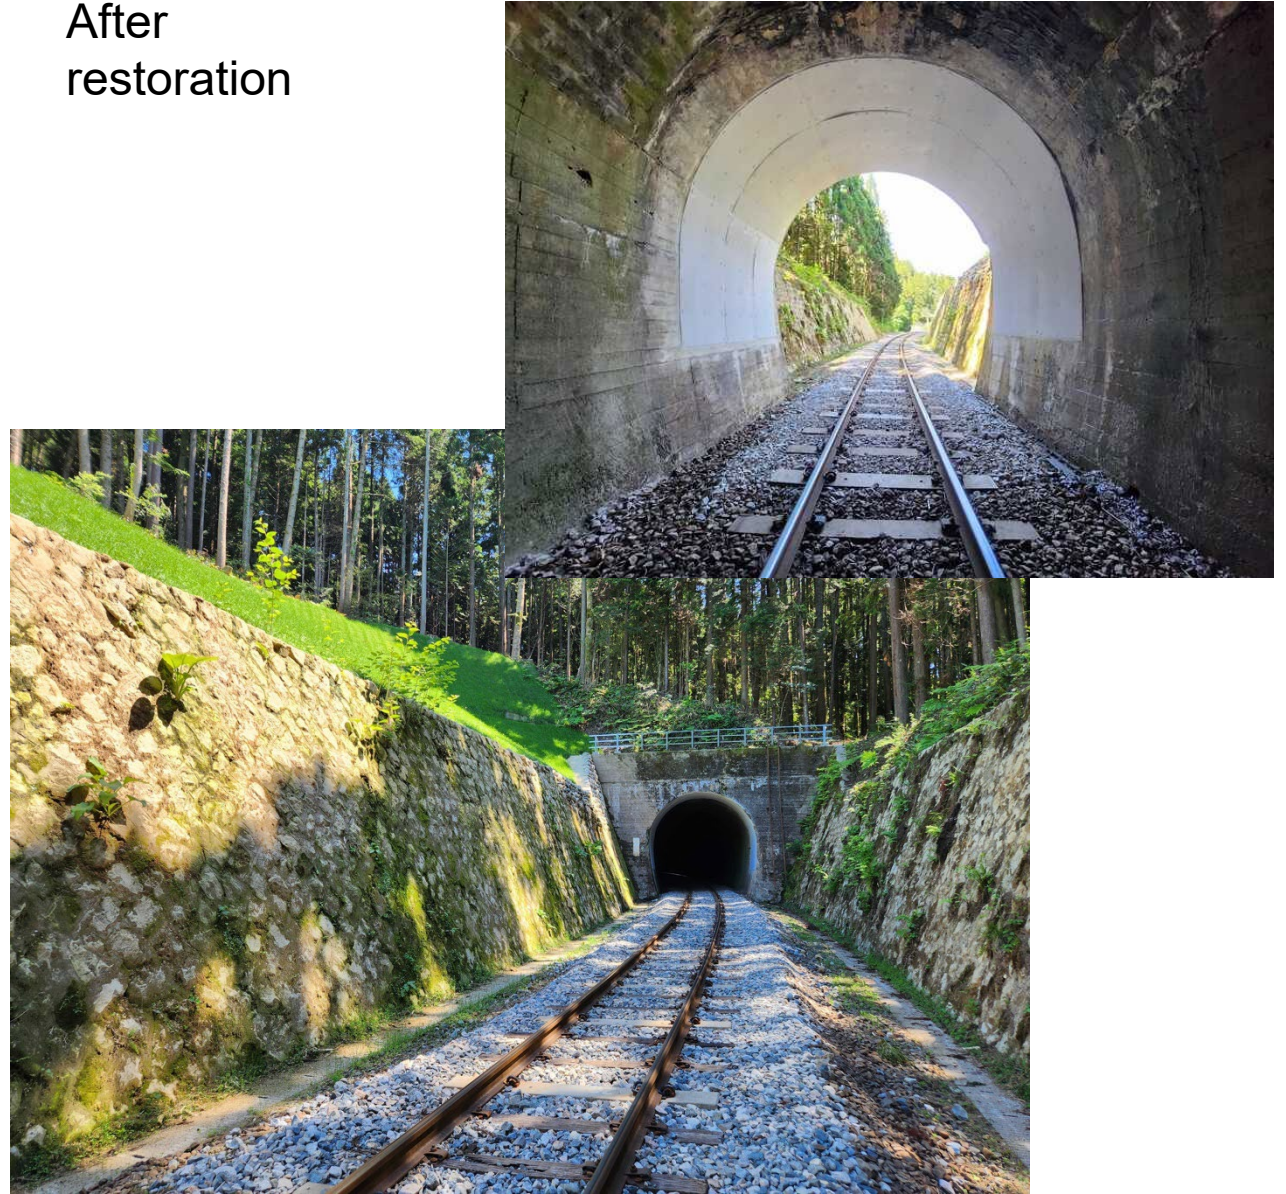
Damage
d

After
restoration

Photo on the left: By the Noto Railway
Photo on the right: By Yoichi Kanayama

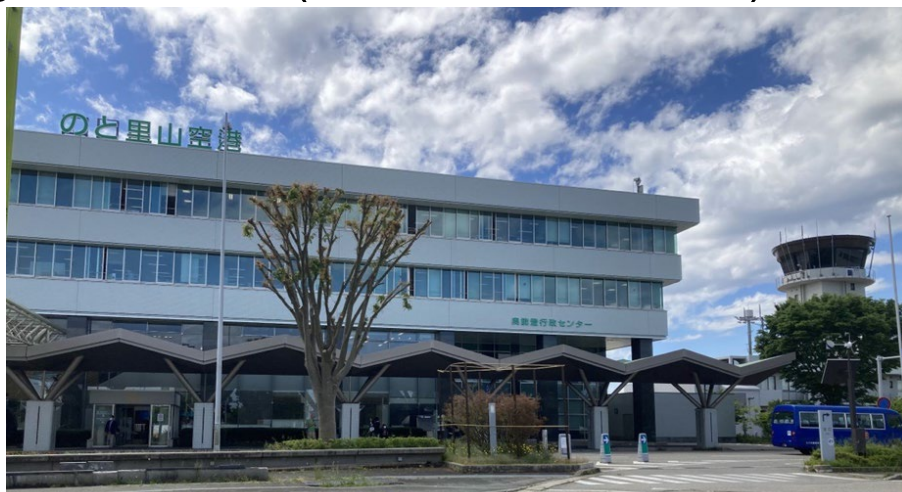
- ✓ Opened in July 2003 (prefecture-managed airport)
- ✓ Runway with the length of 2000m.
- ✓ Administrative facilities (e.g., Branch of Ishikawa Pref. Office)
- ✓ Designated as a roadside station (designated as a disaster prevention roadside station):
- ✓ Japan Aviation Academy (high school & college) opens their campus
- ✓ 2 round-trip flights to Haneda (1 round-trip now after the earthquake)
- ✓ Chartered flights between Taipei
- ✓ 174,544 passengers in 2019 (1,615 international)

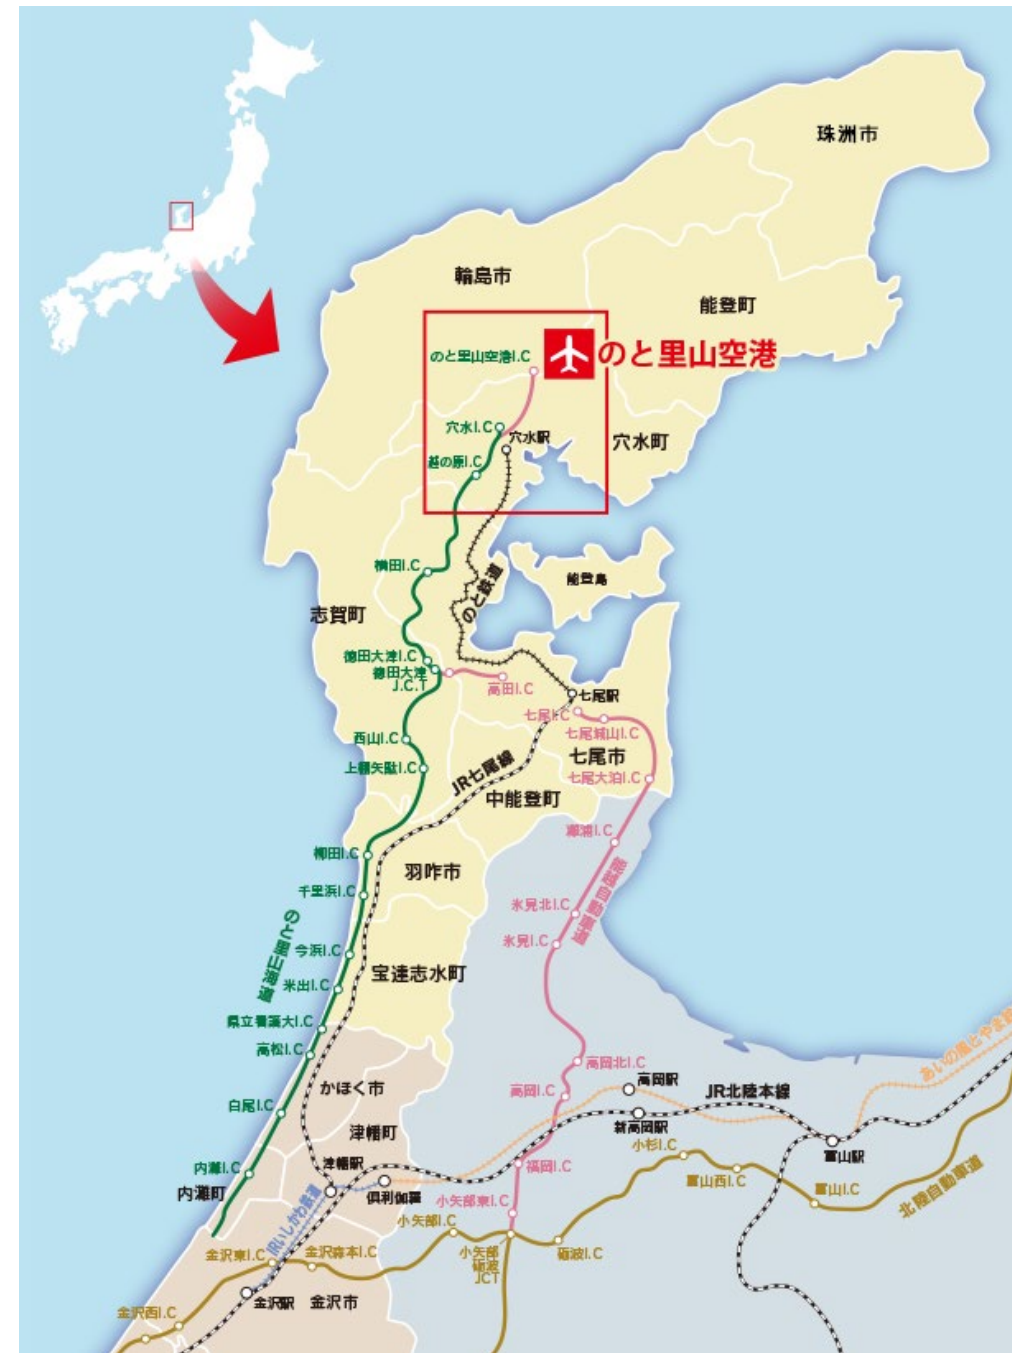
Damage at Noto Satoyama Airport

The red area indicates an
embankment.

Range of
subsidence due to

Range of
occurrence of steps

- Large cracks and steps occurred on the runway, which had been arranged as not requiring seismic countermeasures (e.g., liquefaction countermeasures).
- This is caused by either (1) slip displacement or (2) settlement due to shaking.
- Since no cracks, bulges, or collapses were observed on the slope of the embankment at Noto Airport, it is assumed that settlement due to shaking (2) had an impact.
- The mechanism of the settlement is that the shaking and vibration caused by the abnormalities in the pavement surface
Settlement due to shaking
The soil particles that make up the embankment are rearranged, causing subsidence to occur.

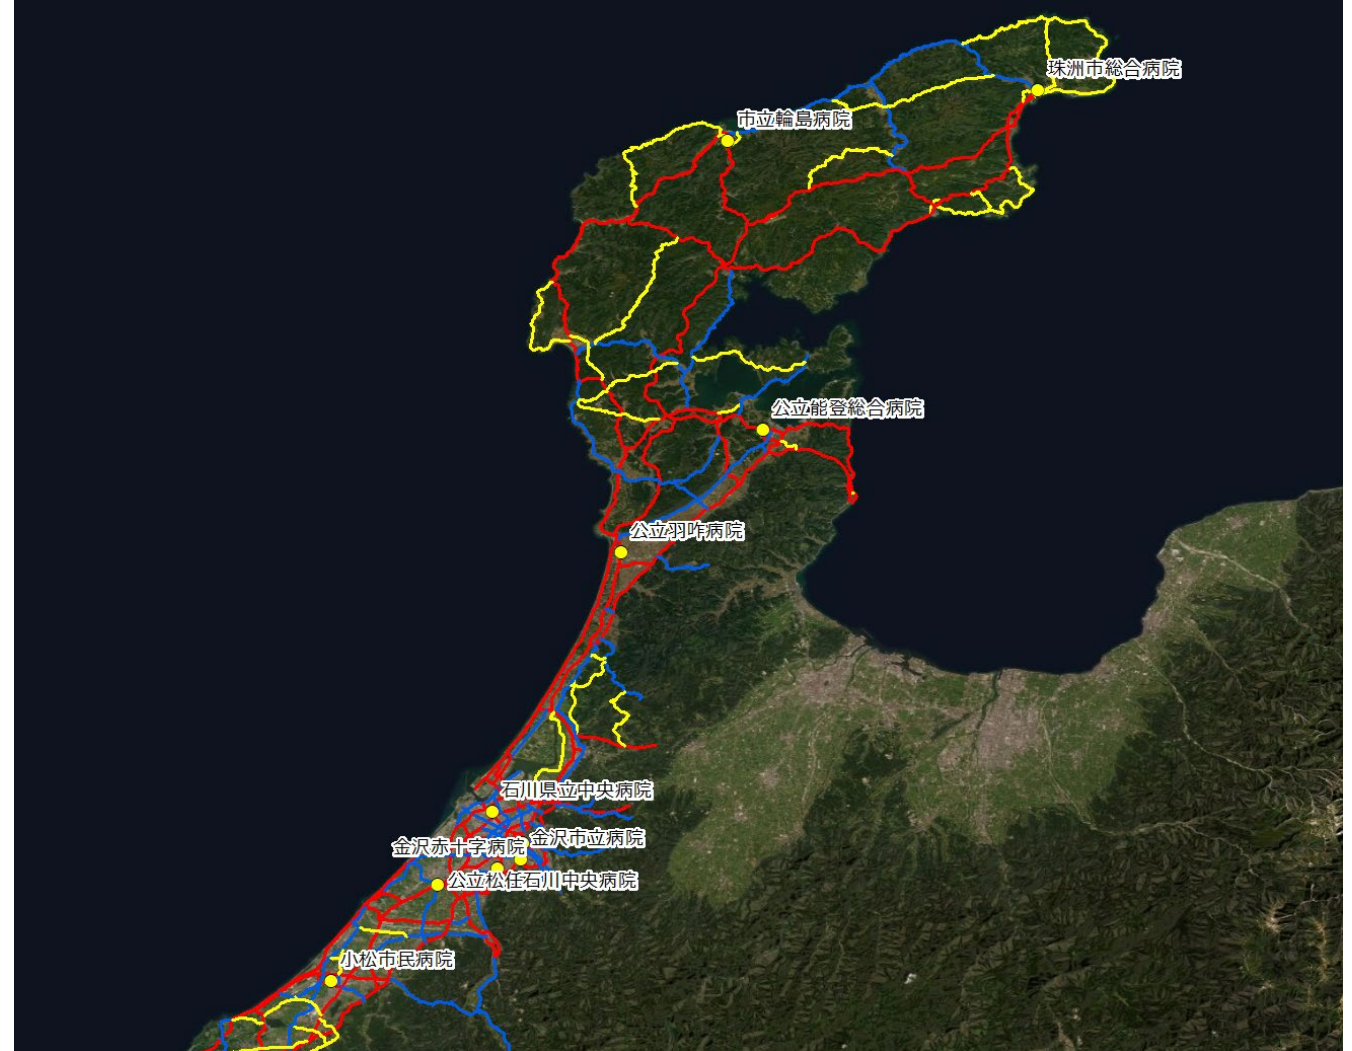
Emergency Transportation Roads and Disaster Base Hospitals in Ishikawa Prefecture

“Double Ladder Shine Bichi (Michi) Concept” (Ishikawa Prefecture, 2016)

Red Road

Primary Emergency Road

Blue Road

Secondary emergency road

Yellow Road

Tertiary Emergency Road

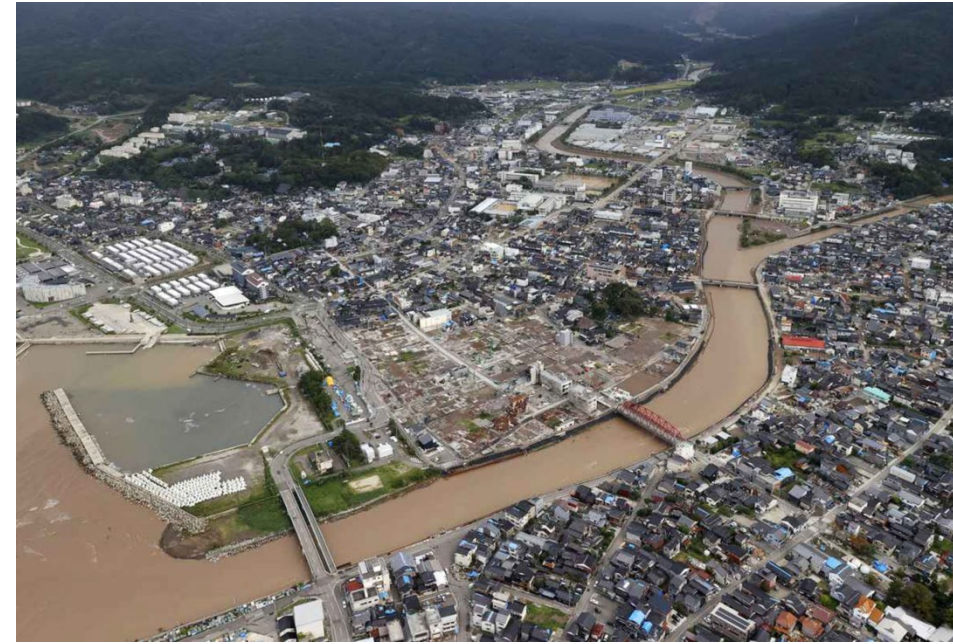
- Torrential rainfall in Noto Peninsula
- September 21-23, 2024
- Number of Deaths: 15
- Landslide locations:
Over 1900

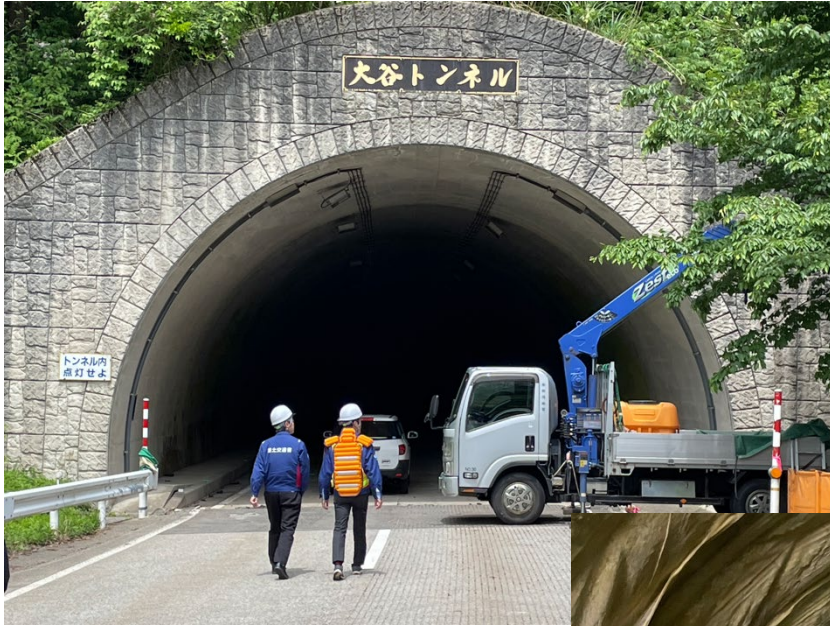
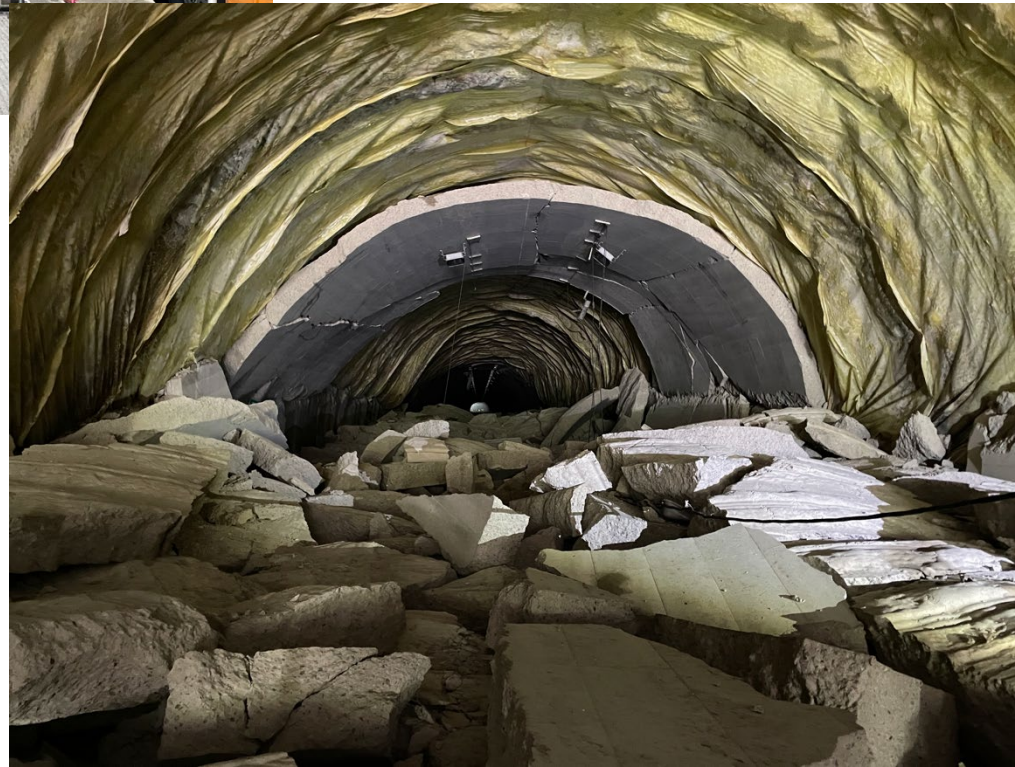
Route 249, Otani Tunnel (Suzu City, photo taken May 15)

Due to a large landslide, over a distance of about 100 meters concrete lining collapsed
