Recent Disaster Responses & Lessons Learned in EASTS Member Countries & Regions

Disaster Response and Adaptation in Rural Areas: The Case of the 2024 Noto Peninsula Earthquake

Daisuke Fukuda
The University of Tokyo

Overview of the Noto Peninsula Earthquake and Damage

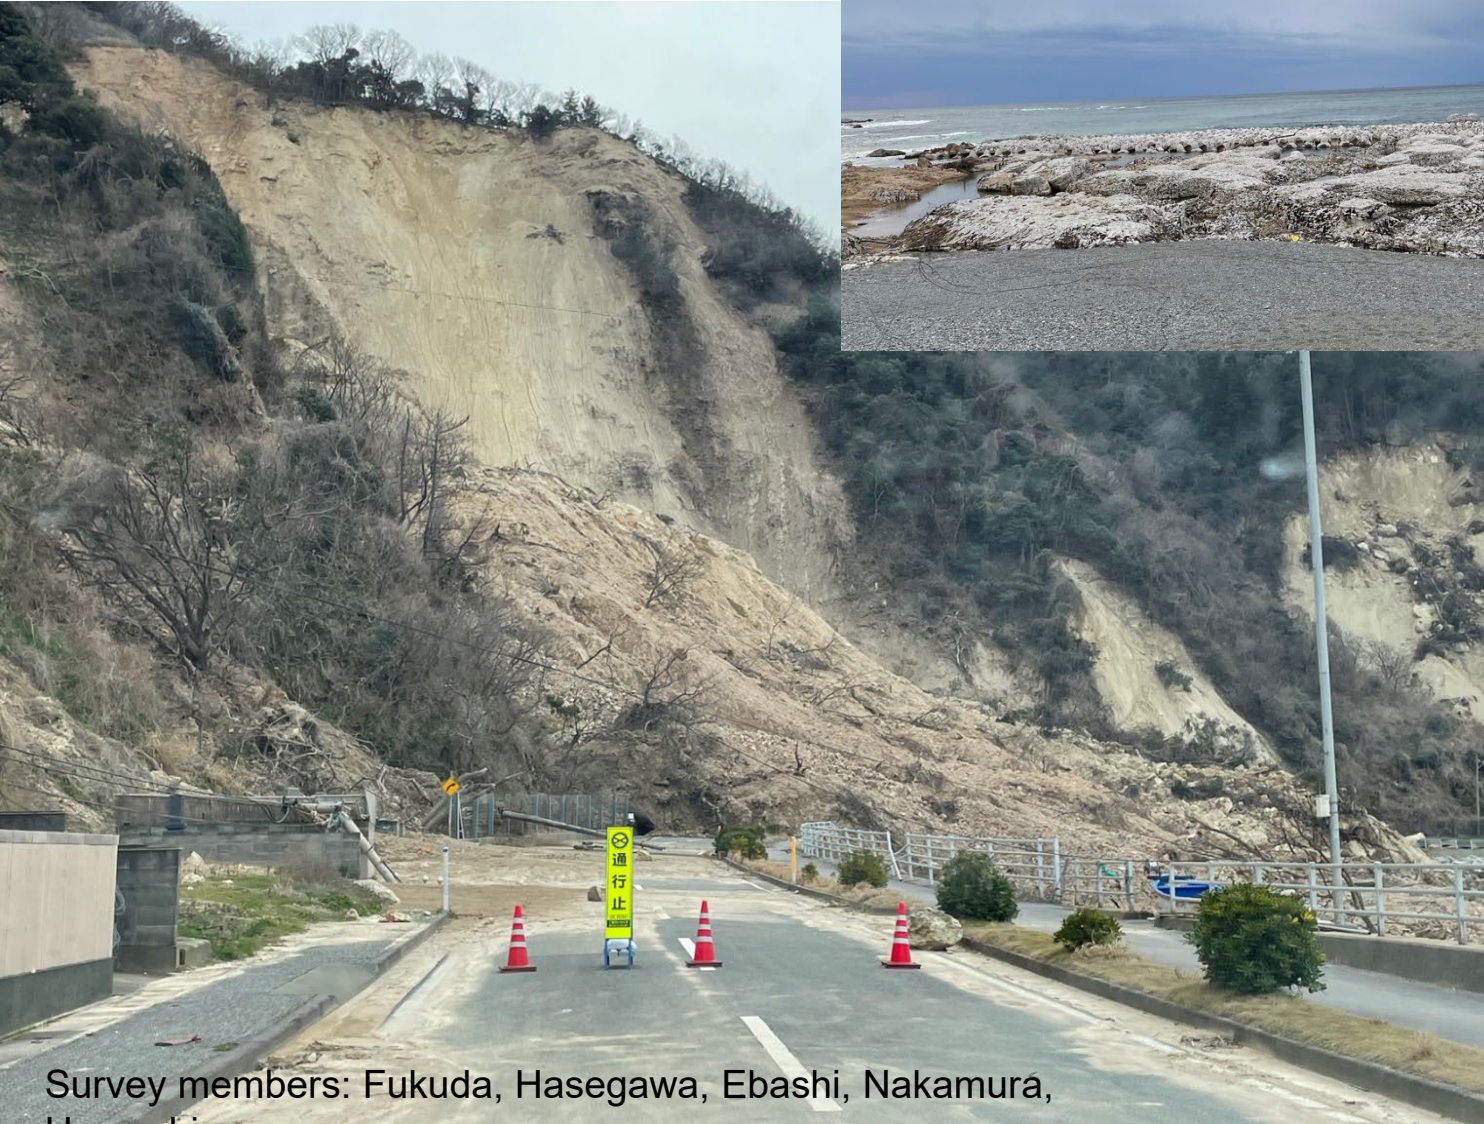
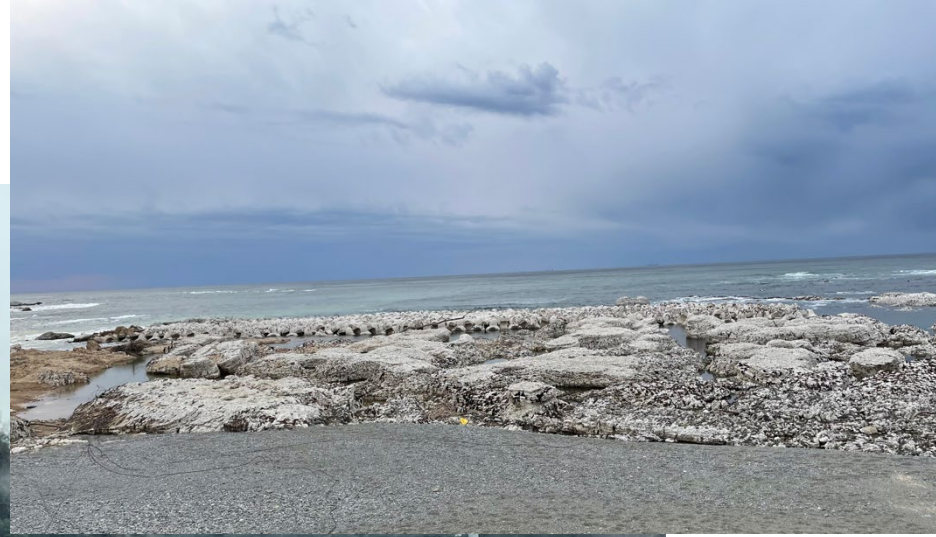
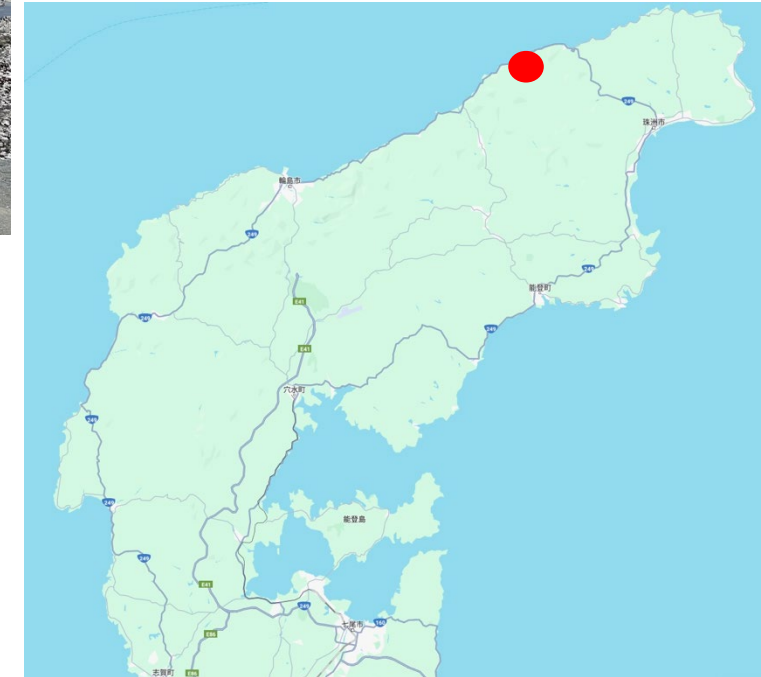
Route 249, near Roadside Station Enden (Suzu City, photo taken March 20)

A total of 85 km of
seafloor was uplift

Road closed due to slope collapse
(The situation is still the same)

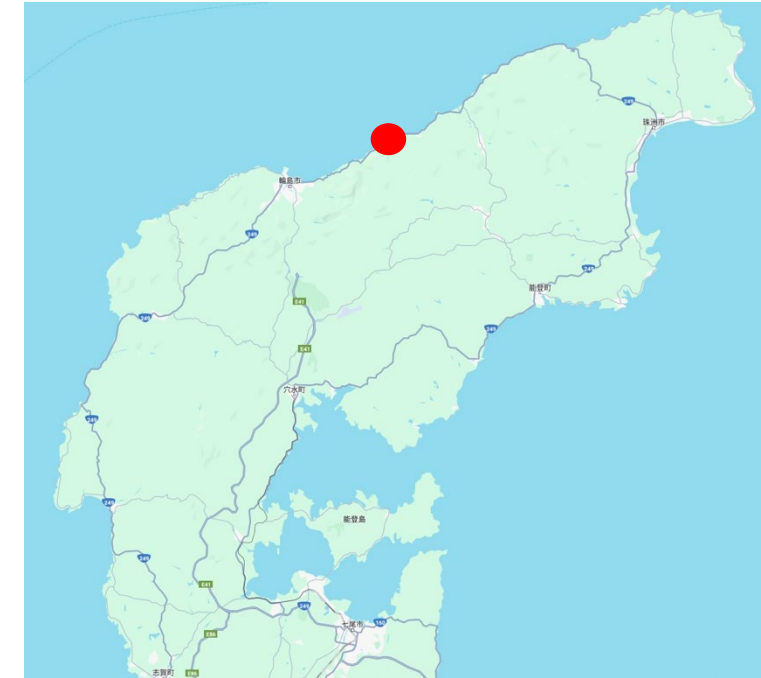
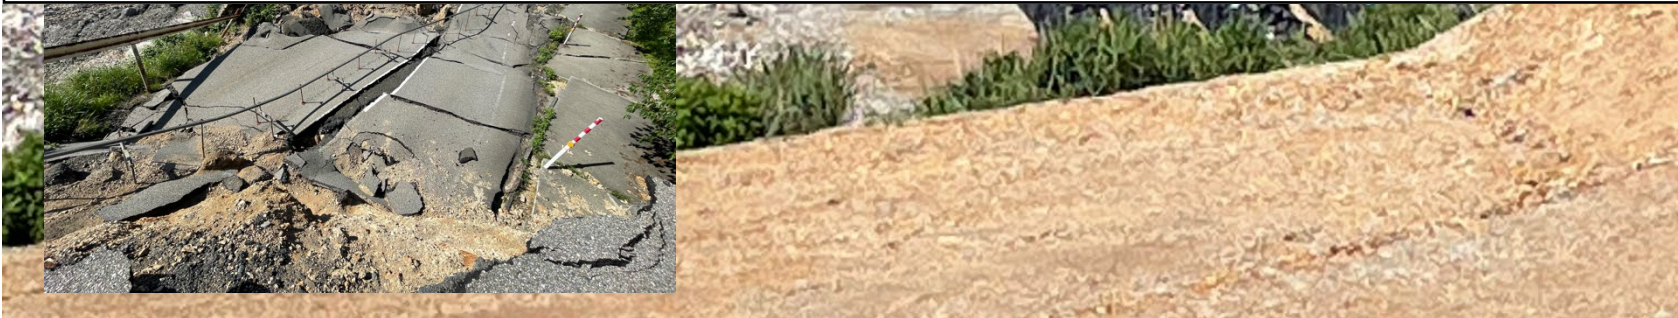
Route 249, near Senmaida Roadside Station (Suzu City, photo taken May 15)

Established an emergency road in the uplifted area.
