PRACTICAL EARTH ANCHORING TECHNOLOGY FOR STRENGTHENING SLOPE WALL PROTECTION (CASE STUDY: DG. SIRUA ROAD POST CONSTRUCTION FAILURE WITH SKYHOOK – GRID BEAM TECHNOLOGY IN MAKASSAR CITY – INDONESIA)

Abstract: The application of soil anchoring system and grid beam method of strengthening protection wall post construction failure was observed in this research. The construction of the slope wall protection is situated to suit the existence of barrier made for aqueduct. Based on the numerical simulation on scenario of potential causes of slope failure, it indicates several phenomena such as the stability of barrier foundation experiences drastic drop. Scrutinizing the result of investigation and ideal design criterion for structural element of barriers, the condition function of existing protection wall has the factor of slope stability $SF=1.01\sim 1.09$, which is categorized as not safe and condition barrier failure. The strengthening method of soil anchoring (Skyhook Earth Anchor, with the capacity of 4 tons) which is combined with grid beam manages to improve the barrier's stability to $SF=1.24\sim 1.46$ post construction and reduce horizontal displacement of barrier.

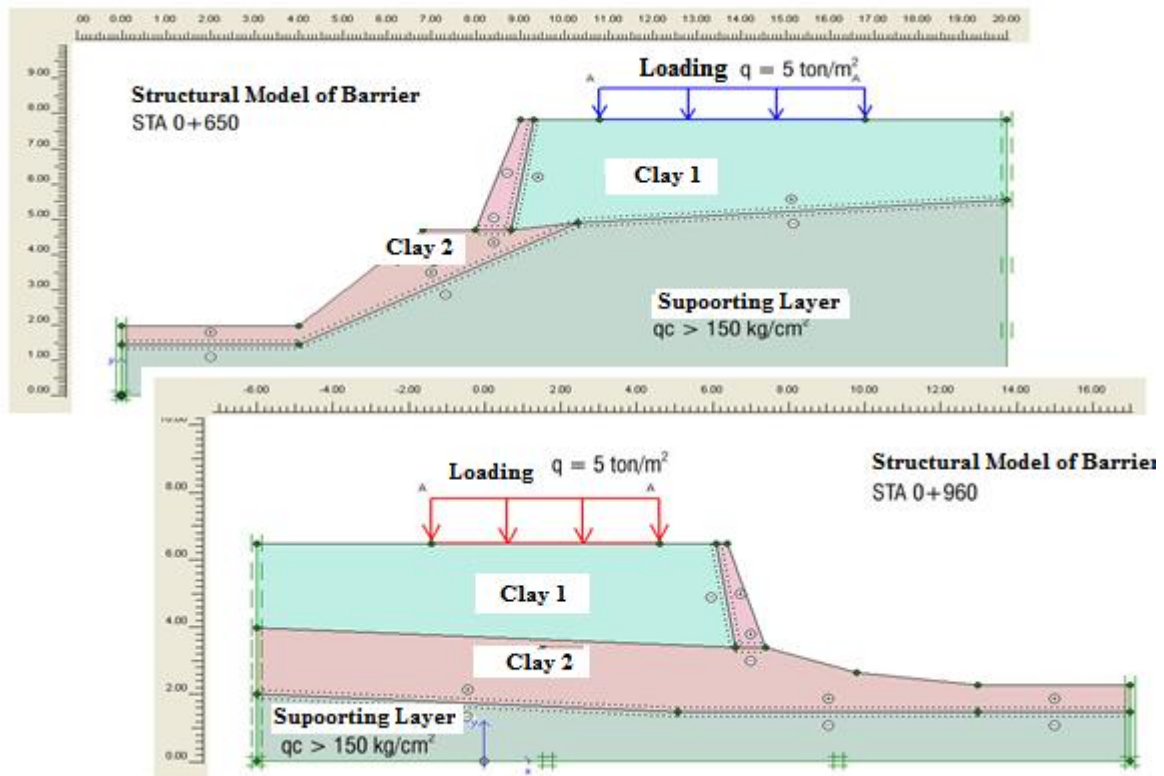
Figure 7 Structural Model of Existing Barrier Jln. Dg Sirua Makassar, Slide Spot 1 (Sta. 0+650) and 2 (Sta. 0+960)

The geometry of barrier which is used on this reinforcement analysis is modelled based on the sectional profile of slide prototype at the slide spot along the road which is illustrated in Figure 7. The mechanism of slide which has occurred is simulated with the packet of numerical simulation and refers to the model of soil profile and the prediction of ground water table when the slide occurred.

- When the slide occurred, the stability factor of slope are SF=1.08~1.09 (Slide Spot 1) and SF=1.01~1.03 (Slide Spot 2), this value of stability is categorized as not safe and the tendency of barrier's failure is high.

Geometry and design parameter of barrier structure which is used in the analysis of strengthening is modelled according to the existing barrier profile in Figure 7. The mechanism of slide which has occurred with the application of SkyHook Earth Anchor is simulated with the same packet of numerical application.
