## APPLICATION OF ADVANCED MEASUREMENT TECHNOLOGY IN EVALUATING ROAD SURFACE QUALITY IN VIETNAM

**Abstract:** Road roughness and surface texture are very important factors, which influence both ride quality and vehicle operating costs. This paper showed the result of RITST on using advanced measurement technologies in checking and evaluating the road surface quality in Vietnam.

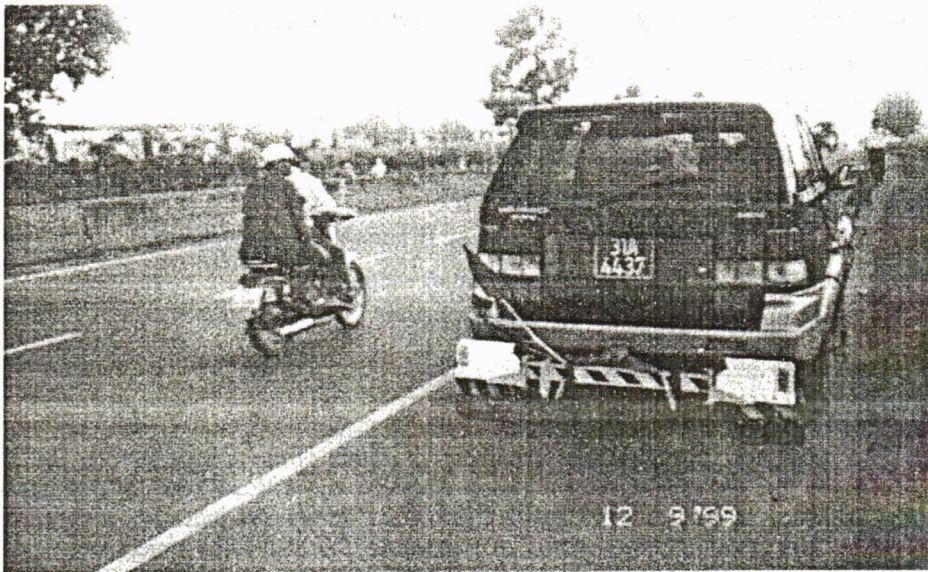
Picture 1. ARRB-2RT Laser Profile

Since 1999 RITST has been using the 2RT Laser Profiler from Australia Road Research ARRB to measurement surface roughness in Vietnam. The ARRB 2RT Laser Profiler system is a laser based instrumentation system mounted on a vehicle. The system acquires the appropriate data needed to measure the pavement surface profile in each wheel path at vehicle speed in range from 30 km/h to 120 km/h. The profile is subsequently analyzed via the Quarter Car model to calculate the International Roughness Index-IRI.

Over view of the ARRB 2RT Laser Profiler can be seen at picture 1.

Considering the success achieved using this method, the 2RT Laser Profiler was performed in September 1999 by repeated IRI measurement in 1km two lane trial section at Highway No.1, whose IRI value had been known already before. Measurements with the Hyundai mounted laser beam need to be repeated 5 times on calibration section with 5 speeds. The IRI results of 5 times running at trial section can be seen at table 1.

Results from trial tests show that The ARRB "2RT Laser Profiler" is independent speed system in IRI roughness measurement.
